No.: H202312204372-08EN

SINORA HARD SHELL
Test report
(Environment Test)

Sample Model : SIN-07146-33BK-E

Test Date : January 19,2024~January 27,2024

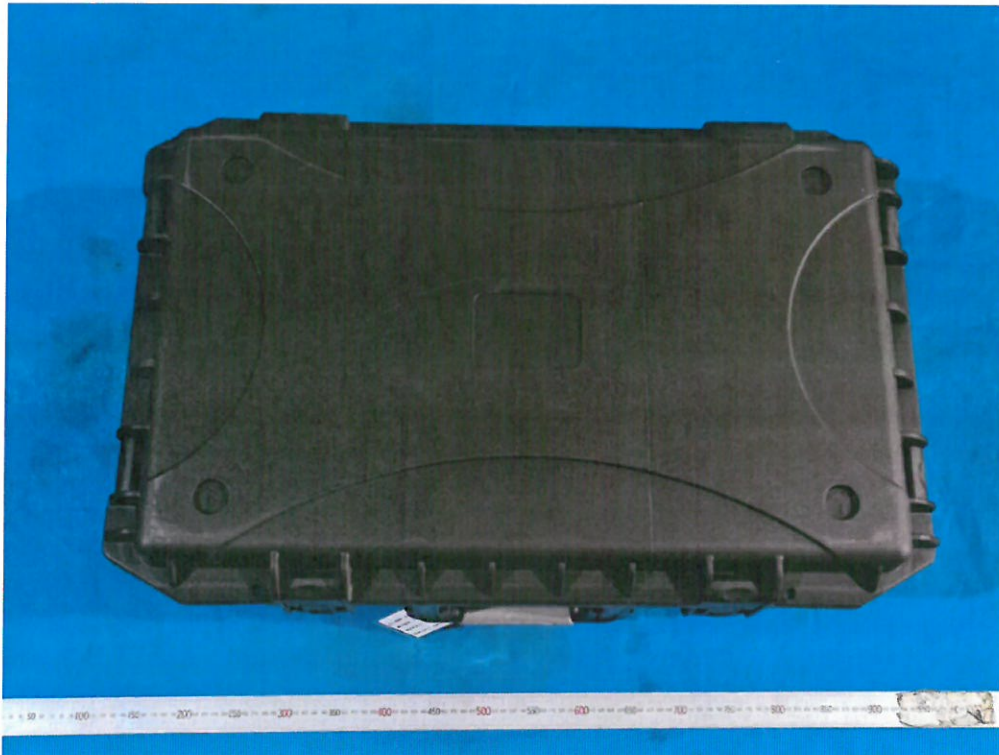
Attached figure 2.18 drawing of appearance inspection of subject
(H202312204372-0008)

| Serial number | Trial items | Test items | Test number | Test requirements and conformity criteria | Test results |
|---|---|---|---|---|---|
| 2 | Check after drop test | Visual inspection | H20231220437 2-0008 | The appearance of the subject should not be cracked, unglued or damaged | Good appearance |
