No.: H202312204372-02EN

SINORA HARD SHELL
Test report
(Environment Test)

GRG METROLOGY & TEST GROUP CO.,LTD.

Sample Model : SIN-04233-27BK-E

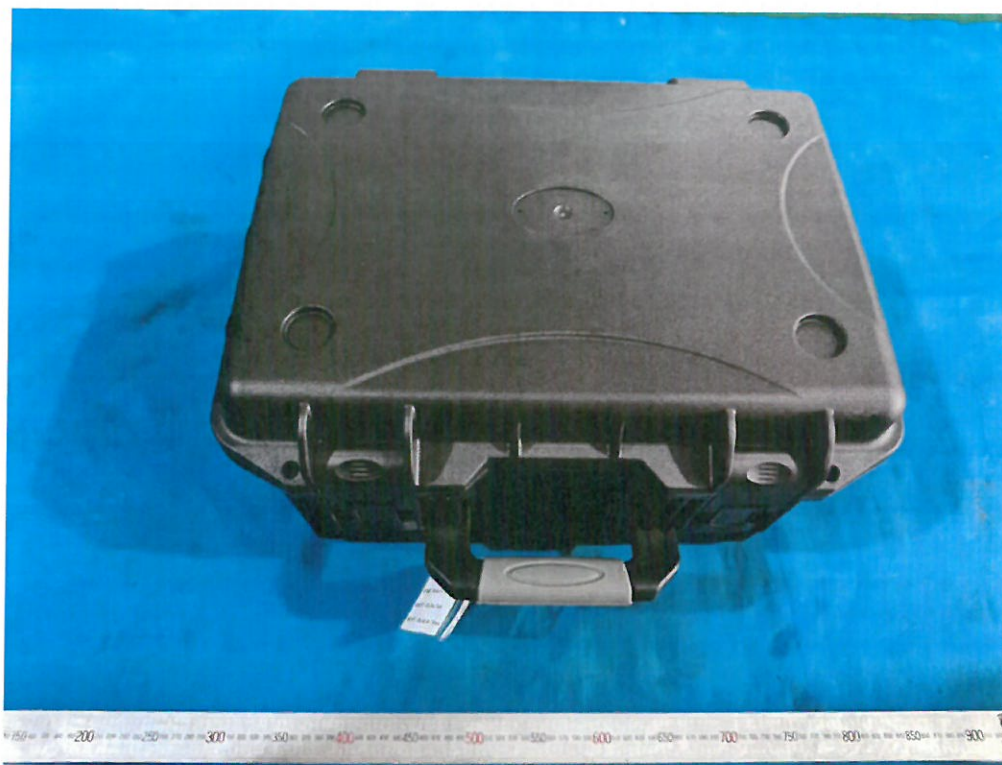
Figure 1-1 Full picture of subjects (Test No. : H202312204372-0002)

See Fig.1-1 for the full picture of the subjects in this experiment。

The subject of this test is a SINORA HARD SHELL, the research and production unit is ProTech Co.Ltd, the quantity is 1 piece, the subject model is SIN-04233-27BK-E, the test number is H202312204372-0002.

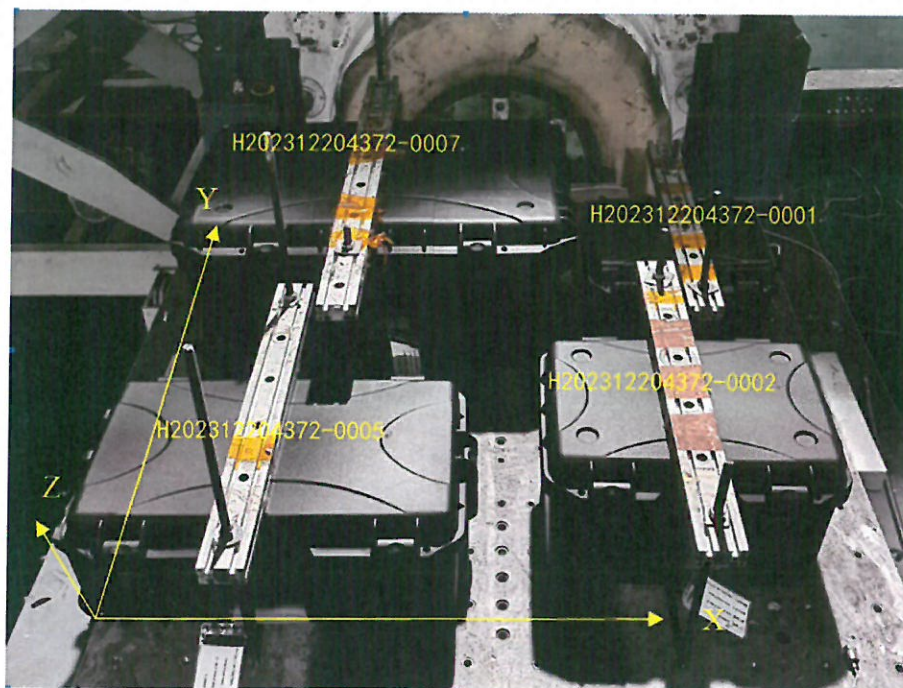
Figure 2-1 Axial definition of the subject

a) Test axis: X axis (transverse), Y axis (longitudinal), Z axis (vertical), axis definition is shown in Figure 2-1, vibration test magnitude is shown in Table 2-1 and Table 2-2.

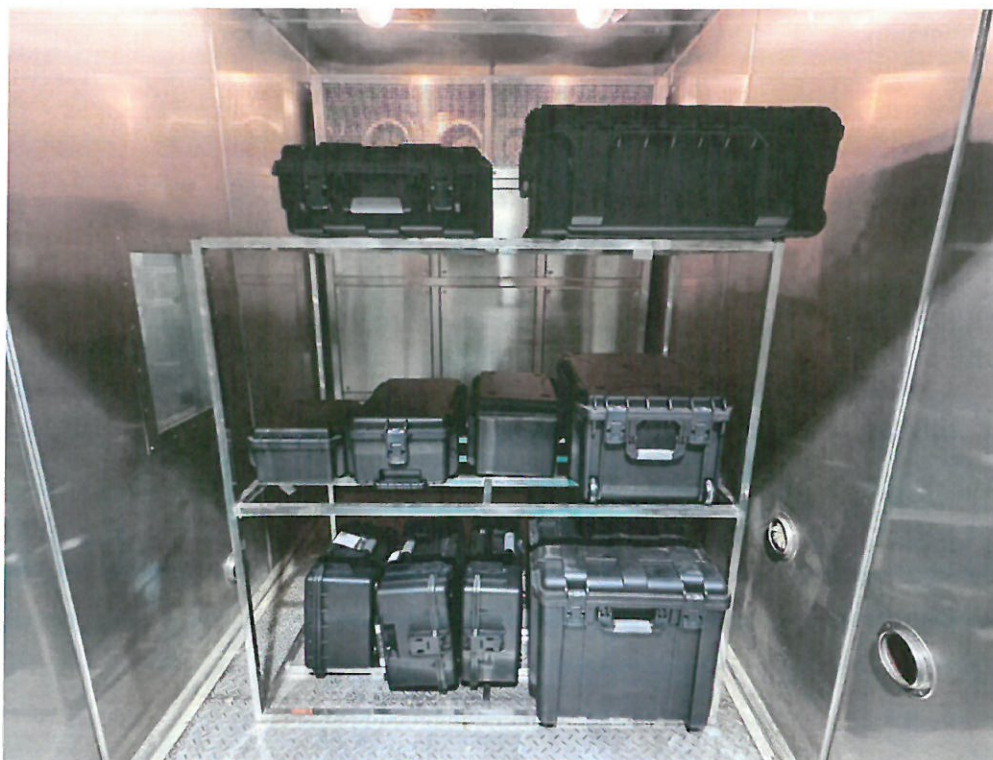
Attached figure 2.1 Temperature shock test subject placement diagram (H202312204372-0002)

Place the test subject flat on the shelf of the temperature impact test box, and in the effective volume of the test box, the air in the box can flow freely. See Attachment 2 for the actual placement status of the subject。

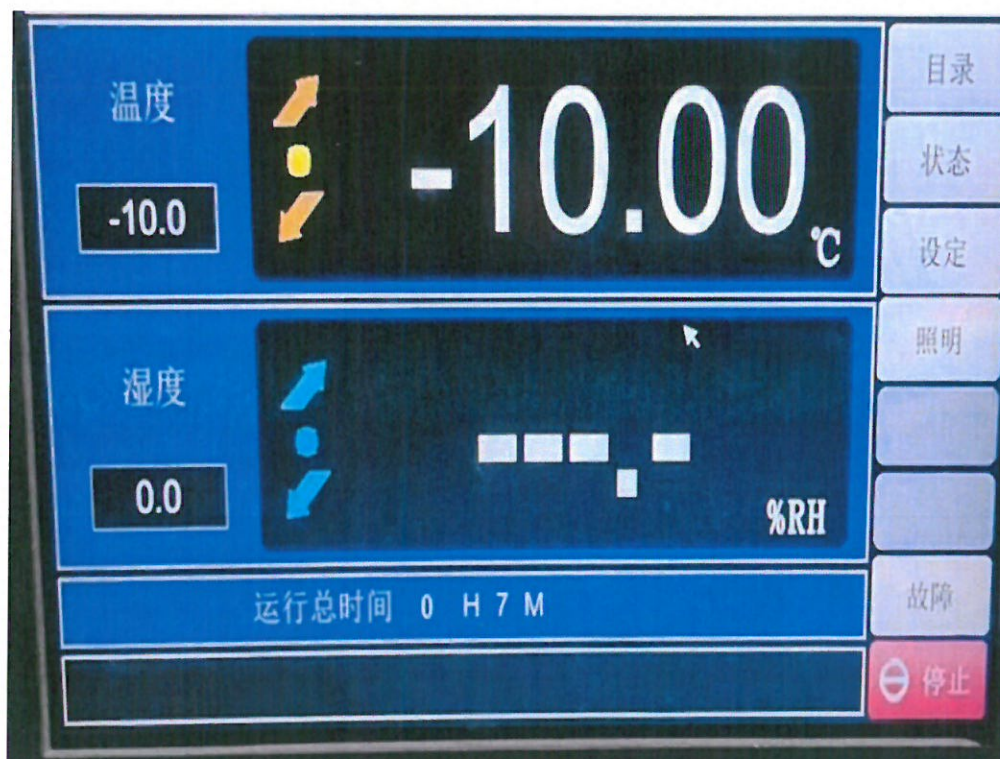
Attached figure 2.4 Temperature shock test equipment running interface-cryogenic box (H202312204372-0002)

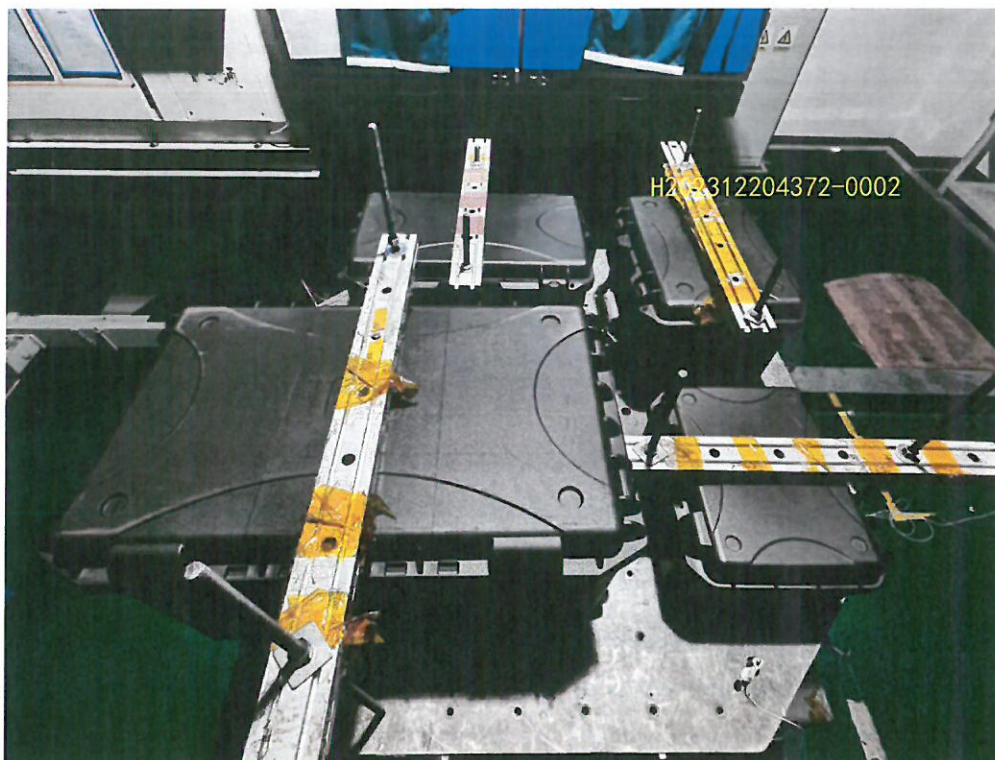
Attached figure 2.5 The vibration test is typically set up by the sample-Z axis
(H202312204372-0002)

The subject is rigorously fixed on the shaking table surface through the aluminum bar and screw, and the control sensor is installed near the connection position of the subject. The two-point average control method is adopted. First, the Z-axis of the subject is examined. See attachment 2 for the actual installation status of the subject.

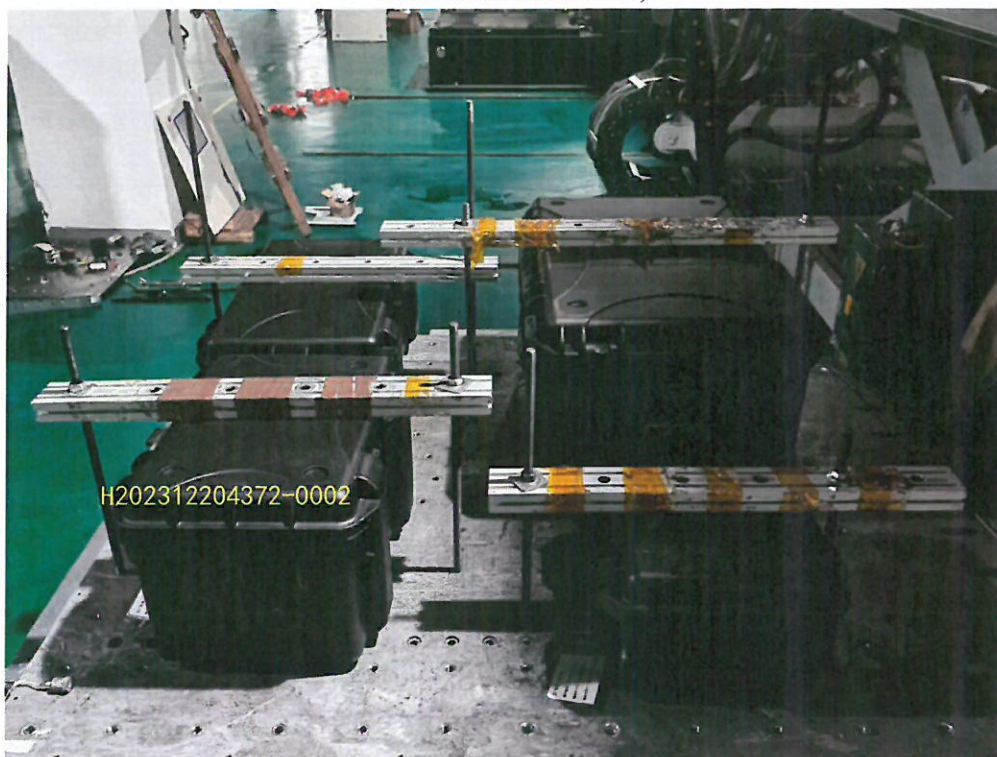
Attached figure 2.5 The vibration test is typically set up by the sample-Y axis
(H202312204372-0002)

Step 2: Change the axial direction of the subject, and conduct the vibration test of the subject in Y axis and X axis for 1h respectively. See Attachment 2 for the actual installation status of the subject.

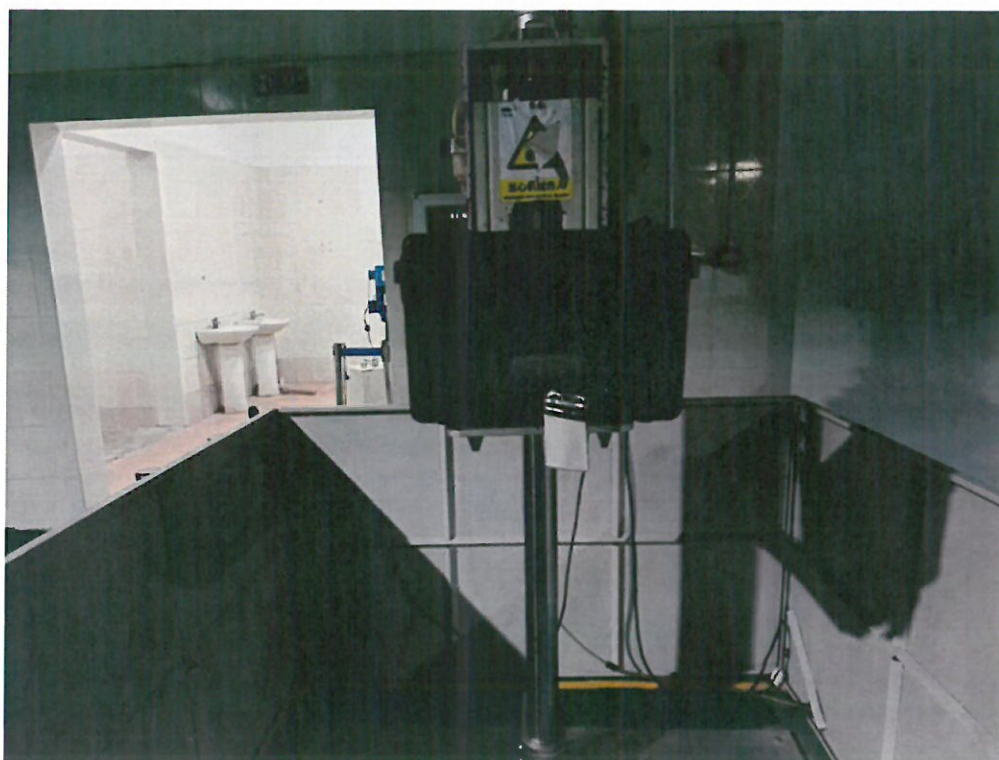
Attached figure 2.16 Drop test subjects set up typical figure-face

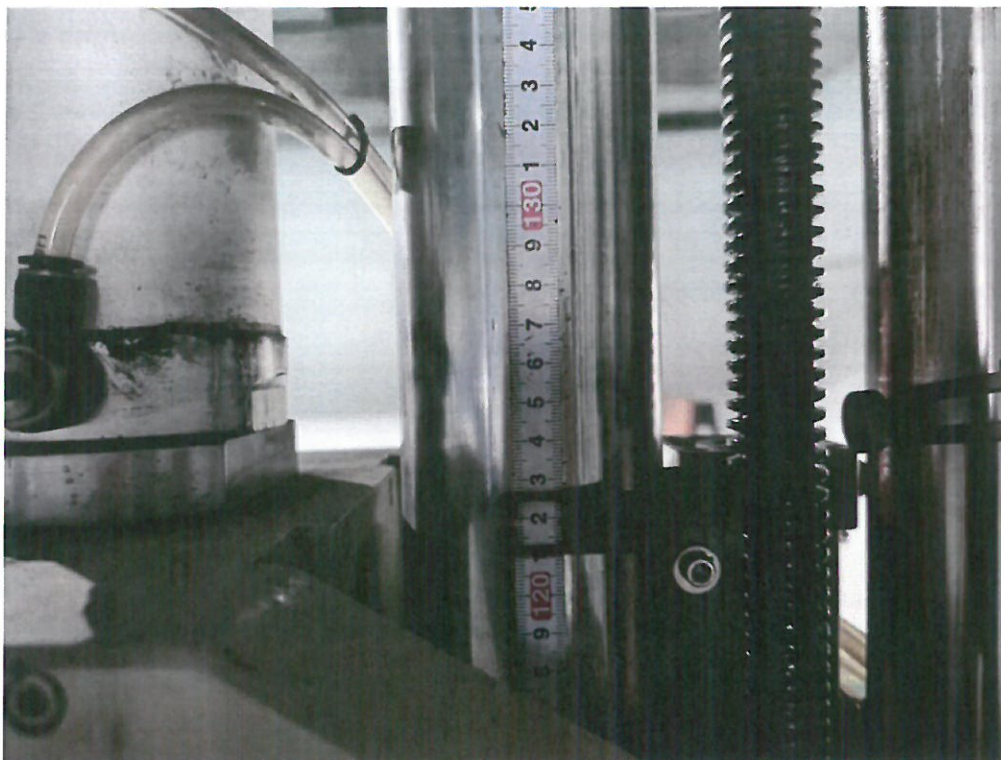
Attached figure 2.17 drawing of drop height 122cm (H202312204372-0002)

Drop surface	Drop height (cm)	Number of falls	Trial number
12 edges	122	Every edge one times, twelve times	H202312204372-0002
8 Angles	122	Every Angle one times, eight times	
6 faces	122	Every face one times, six times

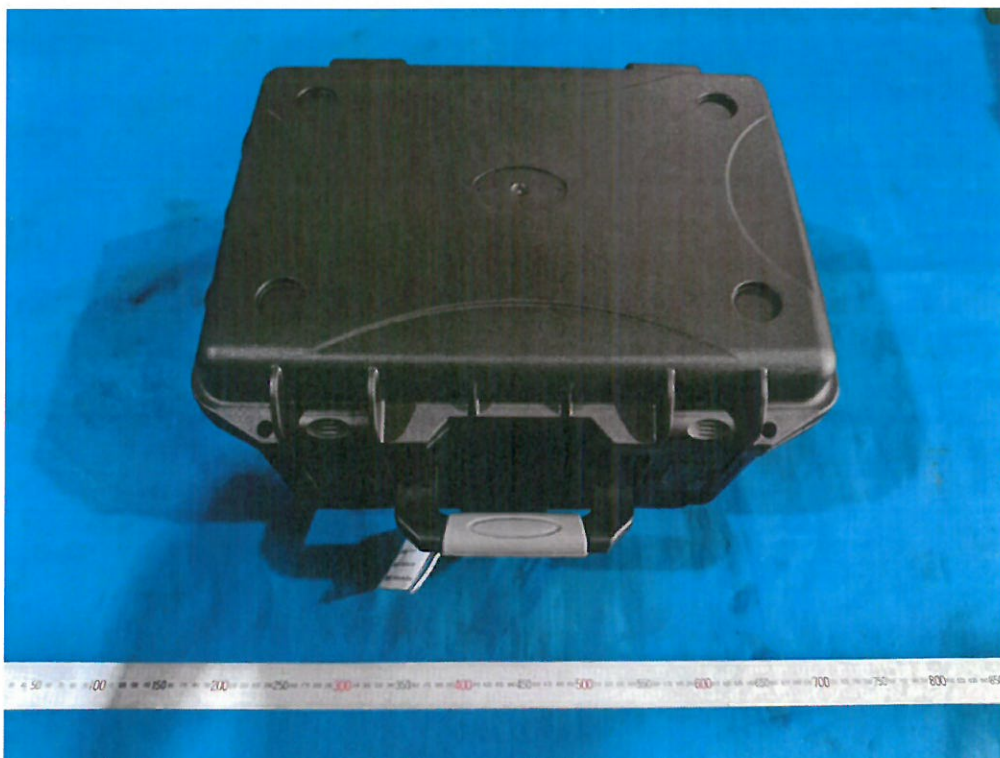
Attached figure 2.18 Typical drawing of appearance inspection of subject
(H202312204372-0002)

Serial number	Trial items	Test items	Test number	Test requirements and conformity criteria	Test results
1	Check before drop test	Visual inspection	H20231220437 2-0002	The appearance of the subject should not be cracked, unglued or damaged	Good appearance
2	Check after drop test	Visual inspection	H20231220437 2-0002	The appearance of the subject should not be cracked, unglued or damaged	Good appearance
