No.: H202312204372-09EN

SINORA HARD SHELL
Test report
(Environment Test)

Sample Model : SIN-07258-53BK-E

Sample Name : SINORA HARD SHELL

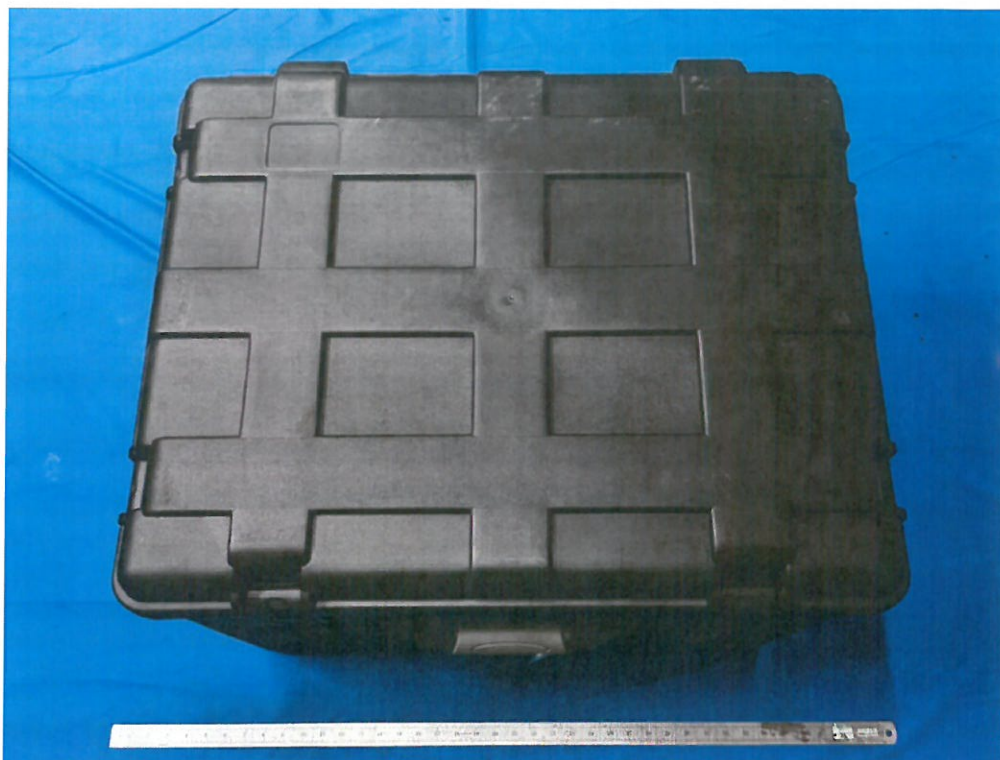
Figure 1-1 Full picture of subjects ((Test No. : H202312204372-0009)

The subject of this test is a SINORA HARD SHELL, the research and production unit is ProTech Co.Ltd, the quantity is 1 piece, the subject model is SIN-07258-53BK-E, the test number is H202312204372-0009.

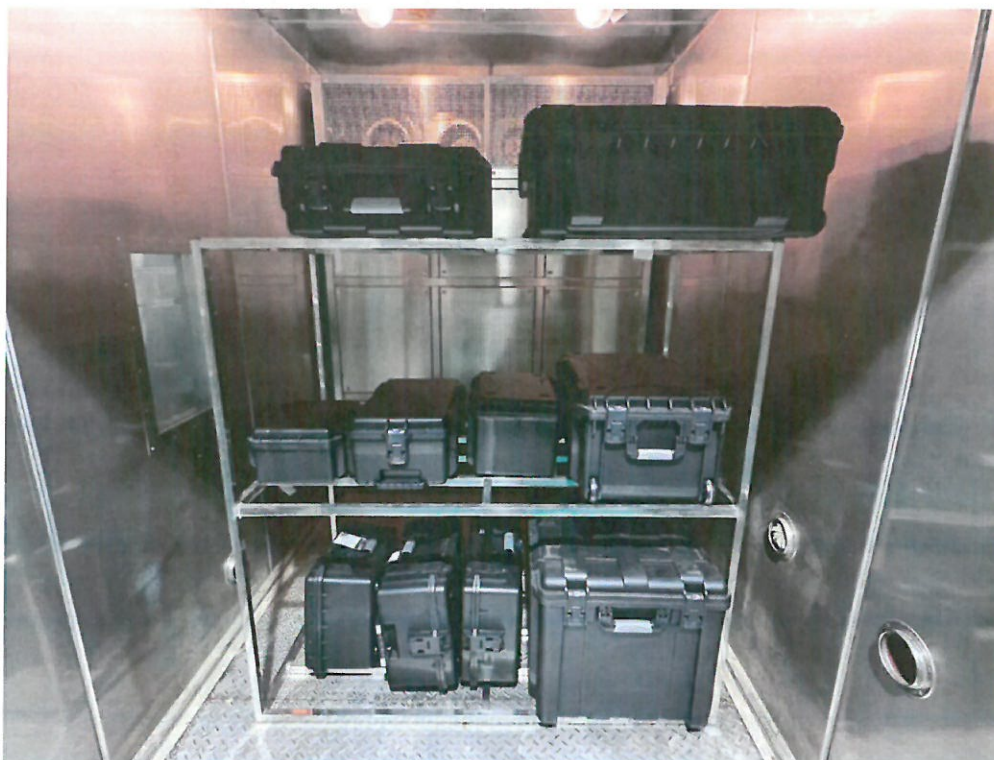
Attached figure 2.1 Temperature shock test subject placement diagram (H202312204372-0009)

Place the test subject flat on the shelf of the temperature impact test box, and in the effective volume of the test box, the air in the box can flow freely. See Attachment 2 for the actual placement status of the subject。

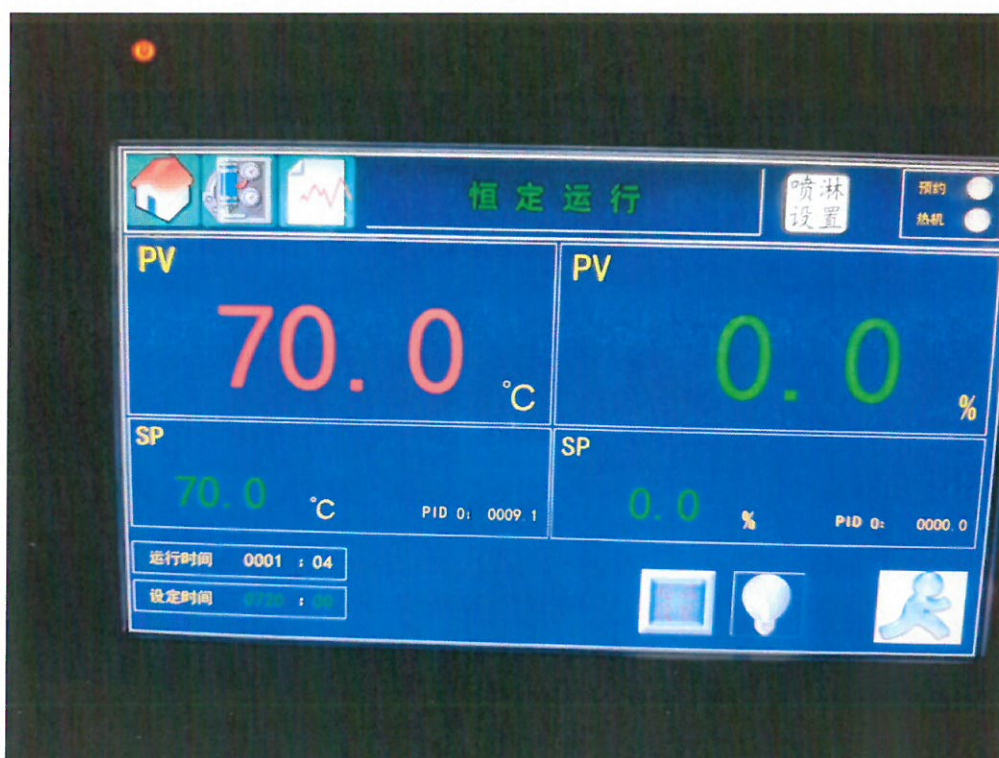
Attached figure 2.2 Temperature shock test equipment running interface - high temperature box (H202312204372-0009)

The temperature shock test is carried out on the subject according to the test conditions specified in 2.1.2. The test started from the low temperature stage. During the test, the high temperature was 70℃, the low temperature was -10℃, the holding time of high and low temperature was 2h, and the conversion time of high and low temperature was about 60s. A total of 3 cycles were carried out。

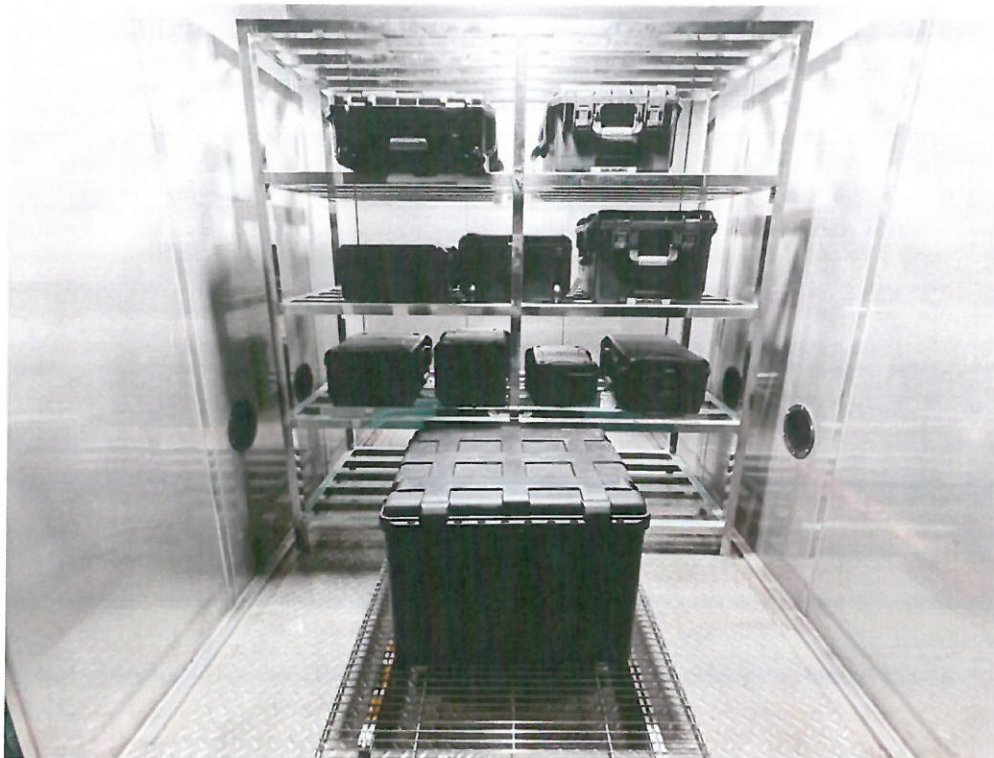
Attached figure 2.3 Temperature impact test subject placement diagram (H202312204372-0009)

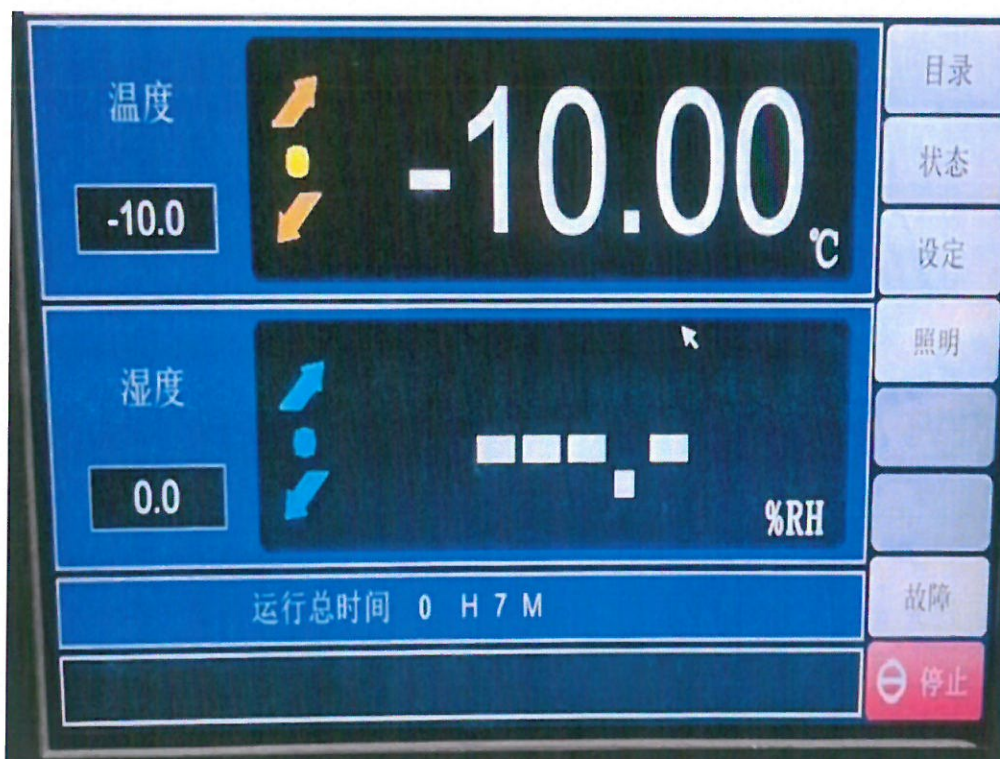
Attached figure 2.4 Temperature shock test equipment running interface-cryogenic box (H202312204372-0009)

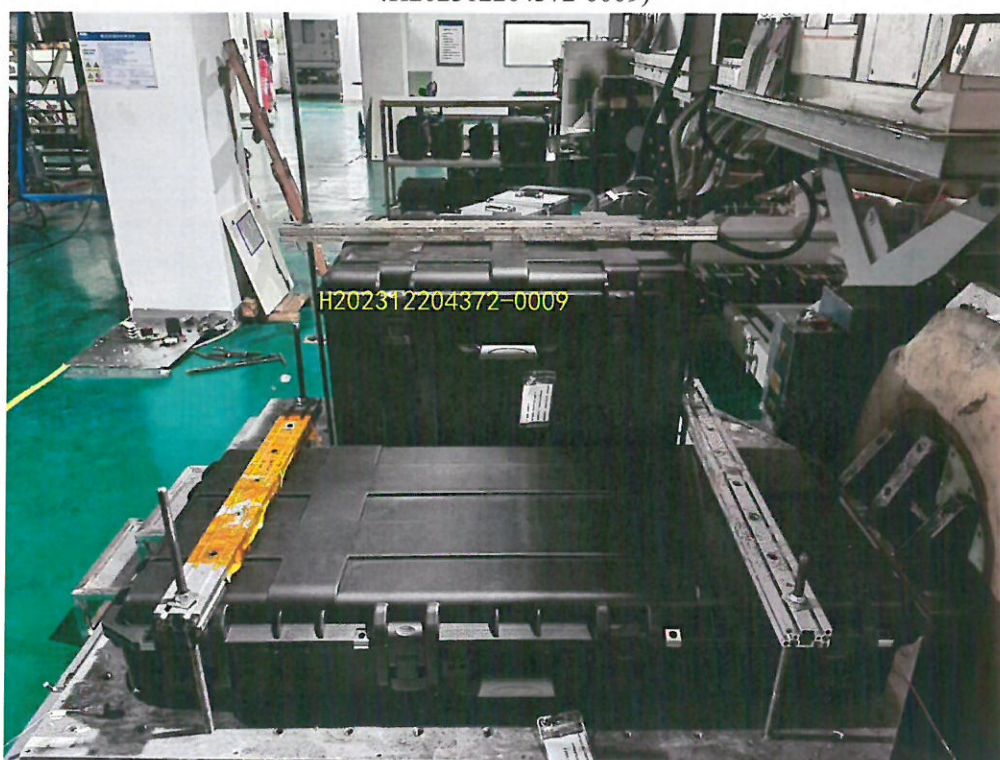
Attached figure 2.6 The vibration test is typically set up by the sample-X axis
(H202312204372-0009)

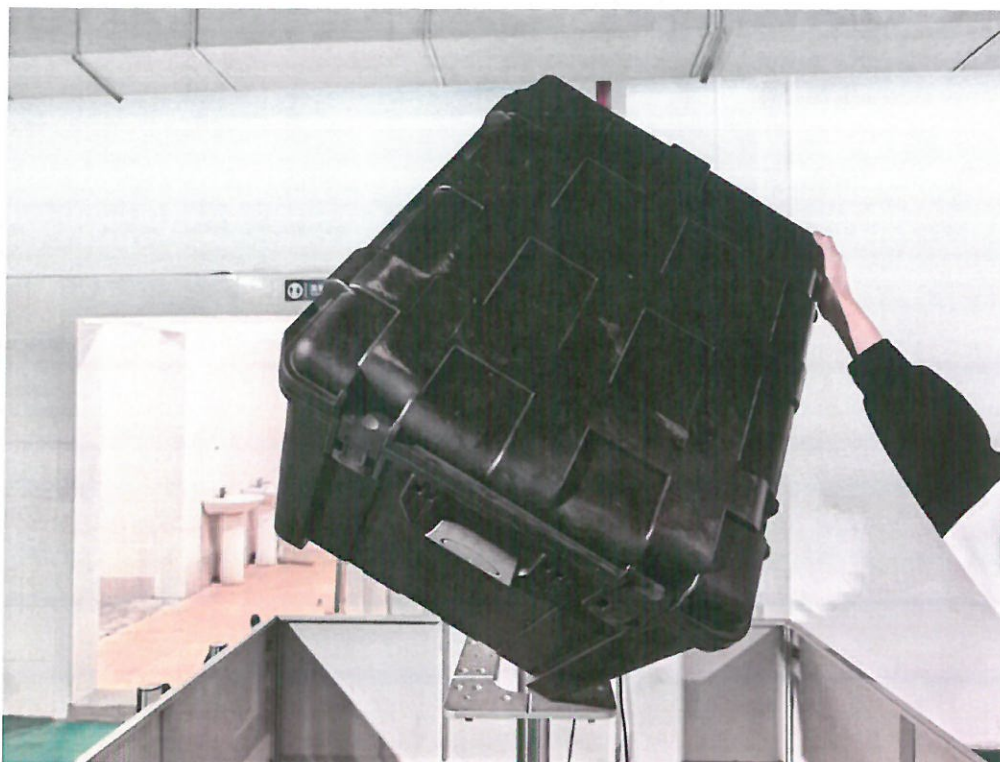
Attached figure 2.15 Drop test subjects set up typical graph-angles

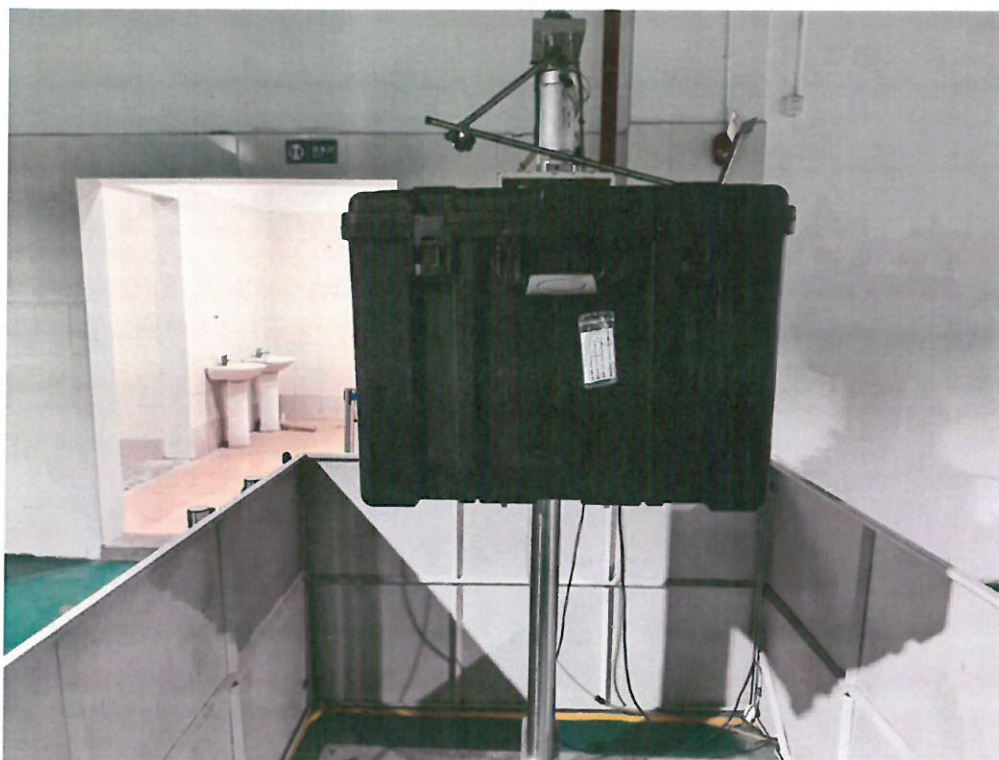
Attached figure 2.16 Drop test subjects set up typical figure-face

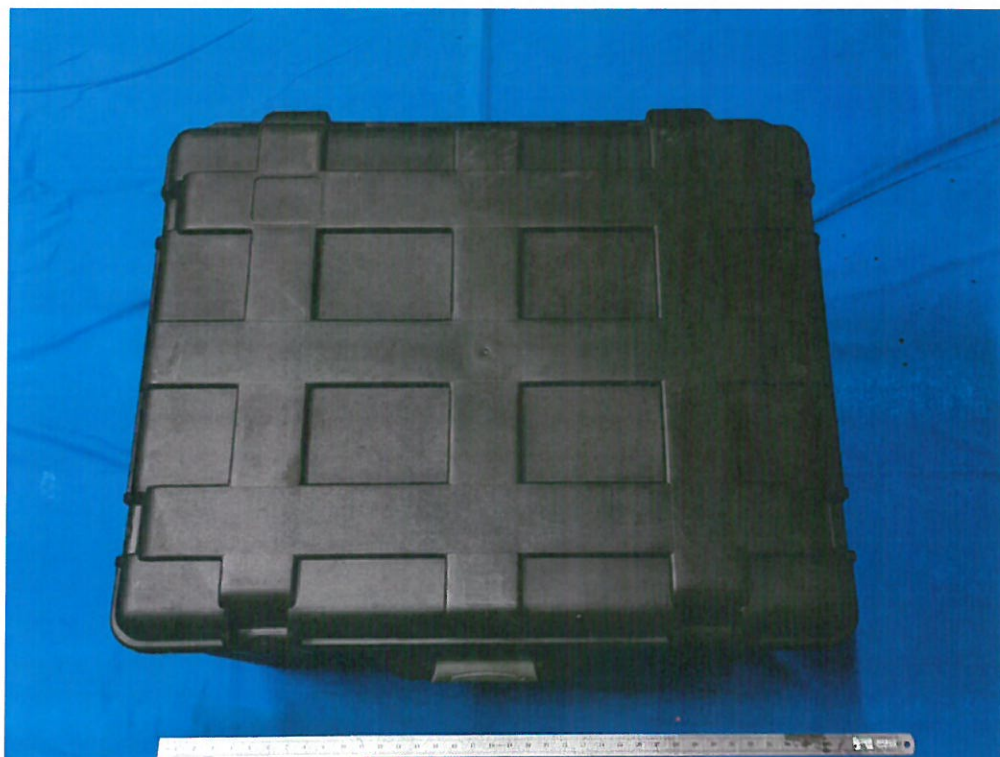
Attached figure 2.18 drawing of appearance inspection of subject
(H202312204372-0009)
