No.: H202312204372-10EN

SINORA HARD SHELL
Test report
(Environment Test)

Customer : ProTech Co.Ltd

Sample Model : SIN-11751-20BK-E

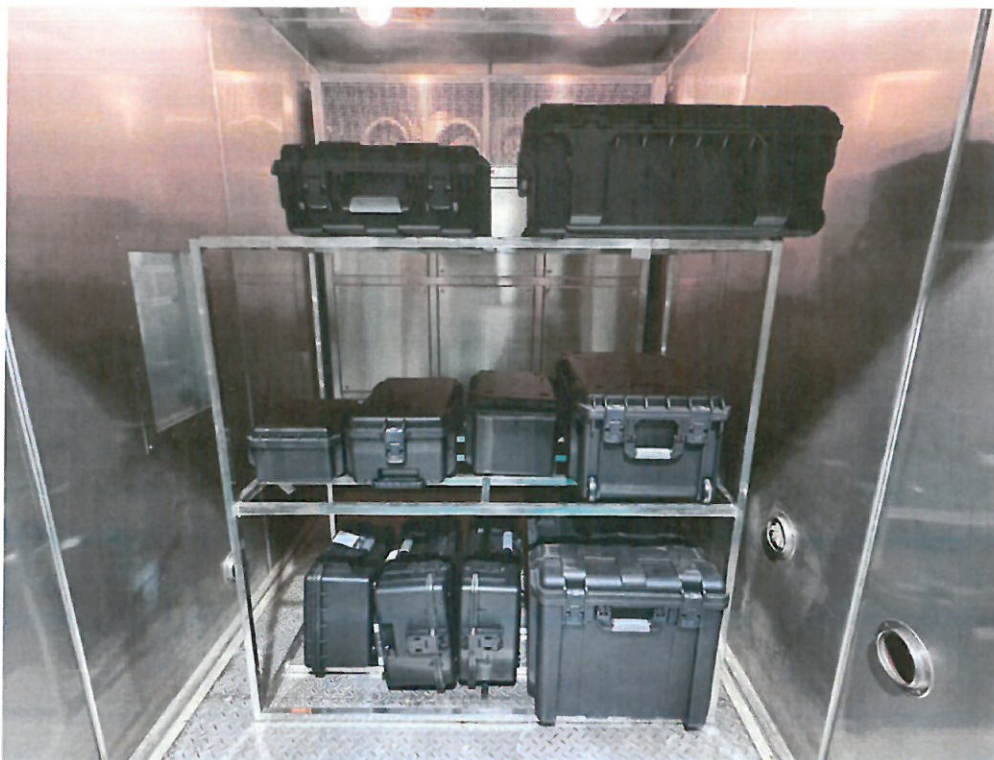
Attached figure 2.1 Temperature shock test subject placement diagram (H202312204372-00100)

Place the test subject flat on the shelf of the temperature impact test box, and in the effective volume of the test box, the air in the box can flow freely. See Attachment 2 for the actual placement status of the subject。

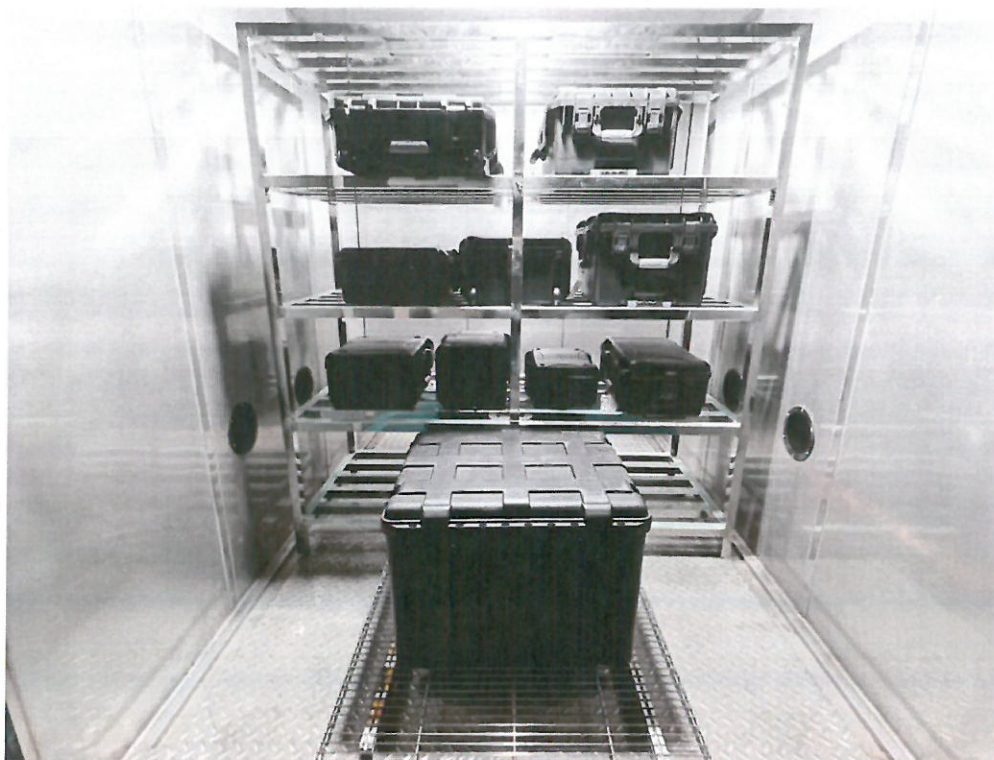
Attached figure 2.3 Temperature impact test subject placement diagram (H202312204372-0010)

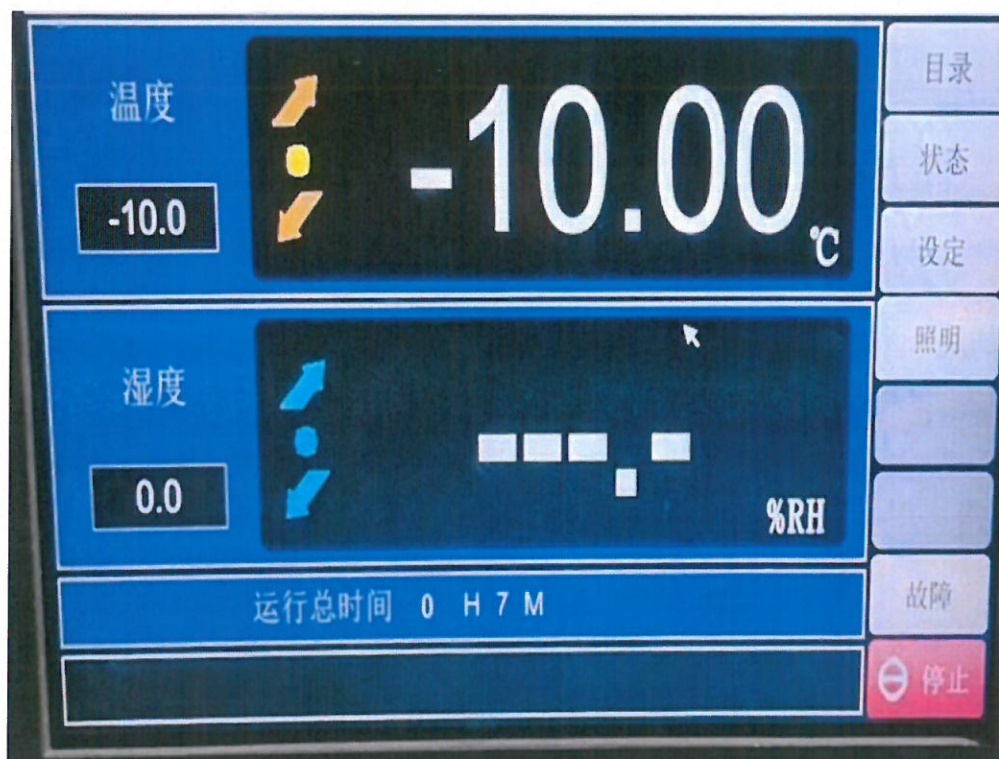
Attached figure 2.4 Temperature shock test equipment running interface-cryogenic box (H202312204372-0010)

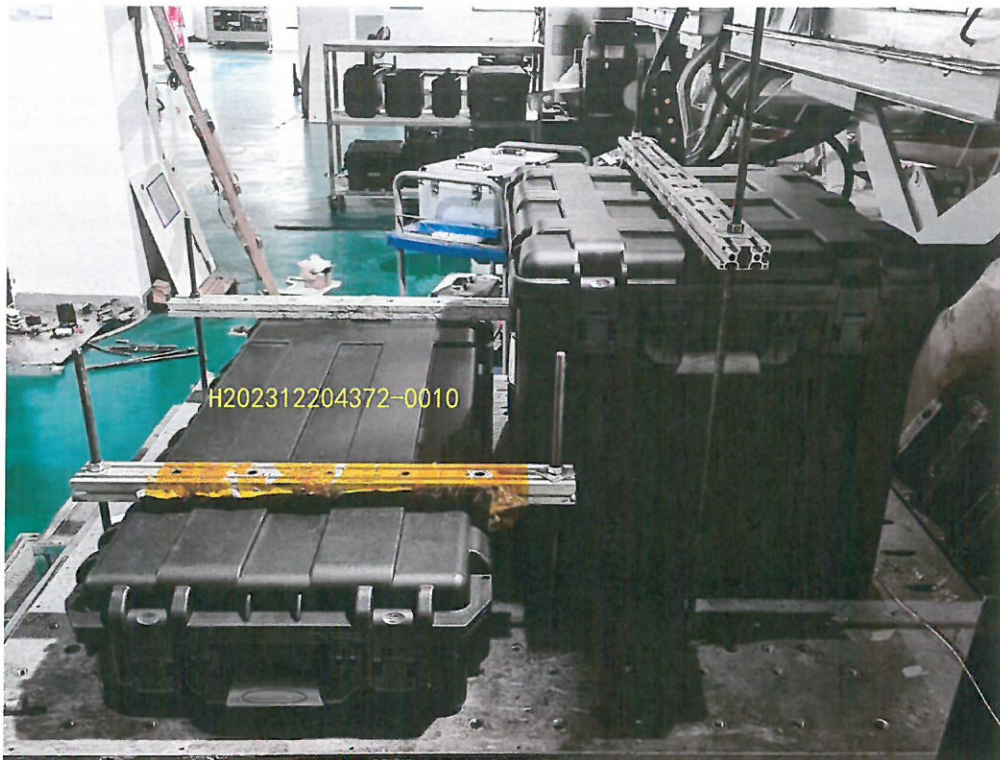
Attached figure 2.5 The vibration test is typically set up by the sample-Y axis
(H202312204372-0010)

The subject is rigorously fixed on the shaking table surface through the aluminum bar and screw, and the control sensor is installed near the connection position of the subject. The two-point average control method is adopted. First, the Y-axis of the subject is examined. See attachment 2 for the actual installation status of the subject.

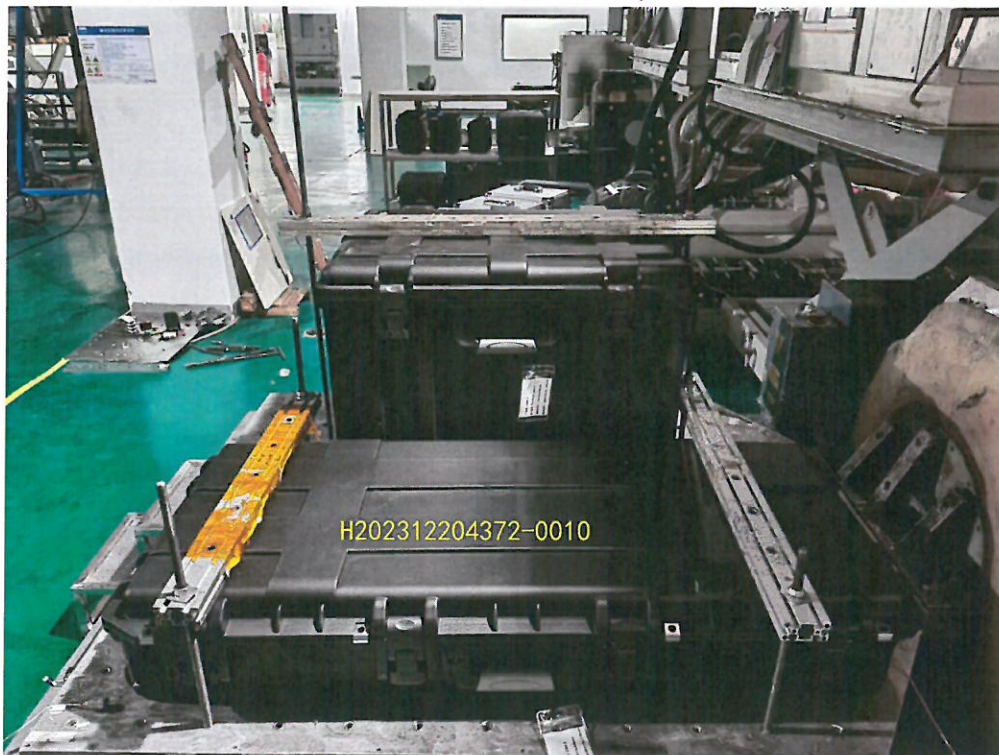
Attached figure 2.6 The vibration test is typically set up by the sample-X axis
(H202312204372-0010)

Step 2: Change the axial direction of the subject, and conduct the vibration test of the subject in X axis and Z axis for 1h respectively. See Attachment 2 for the actual installation status of the subject.

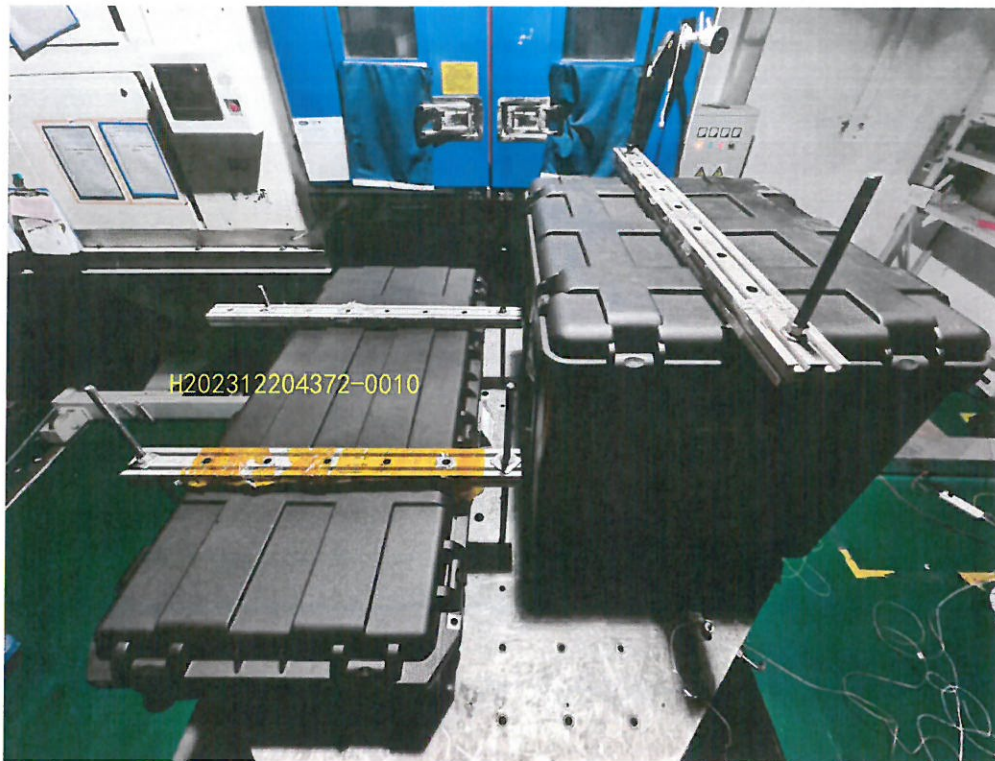
Attached figure 2.7 The vibration test is typically set up by the sample-Z axis
(H202312204372-0010)

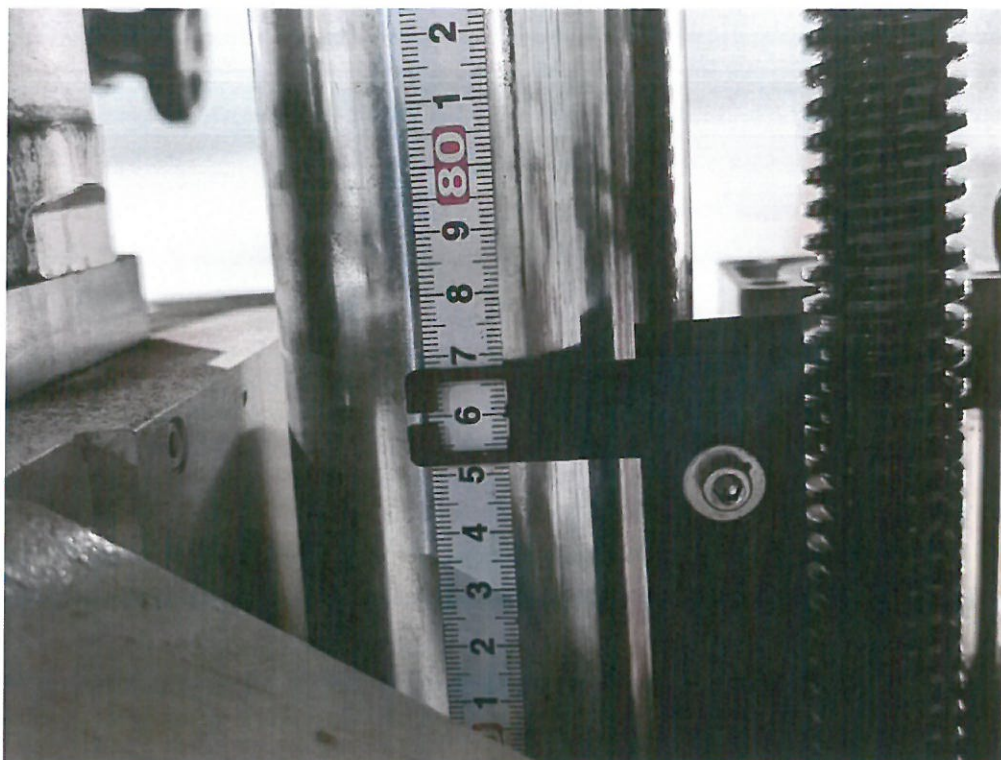
Attached figure 2.17 drawing of drop height 76cm (H202312204372-0010)

Drop surface	Drop height (cm)	Number of falls	Trial number
12 edges	76	Every edge one times, twelve times	H202312204372-0010
8 Angles	76	Every Angle one times, eight times	
6 faces	76	Every face one times, six times

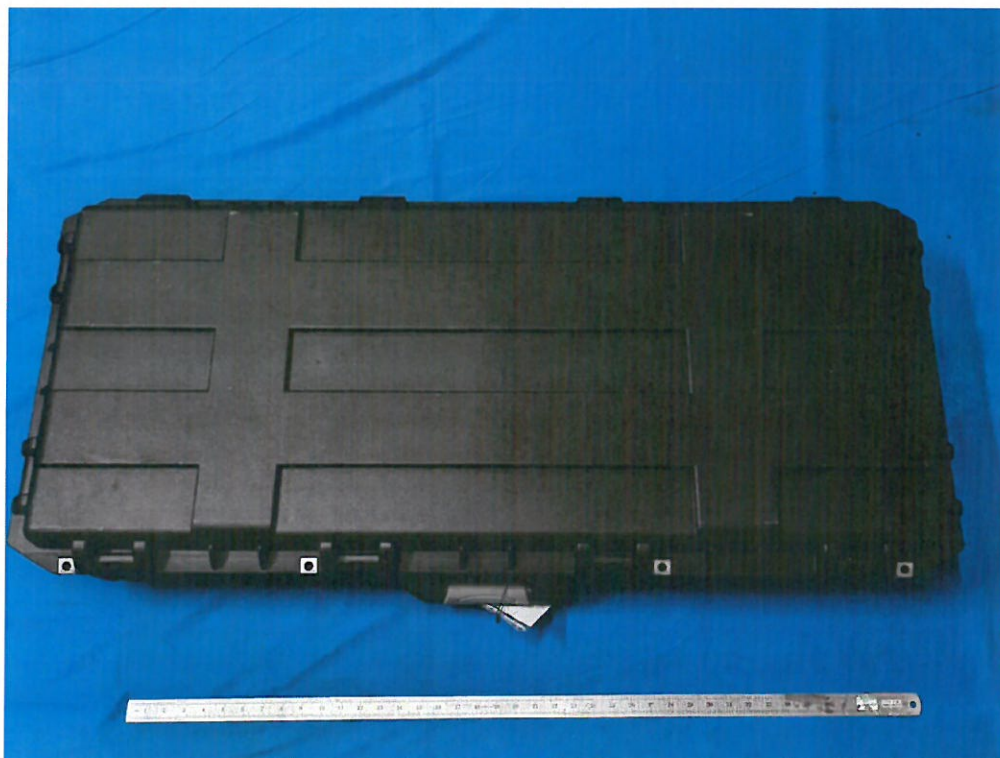
Attached figure 2.18 drawing of appearance inspection of subject
(H202312204372-0010)
