Test Report

Report No.:H202403271022-04EN

Sample Name: SINORA HARD SHELL

Reference
Document: According to ISO 20653:2013

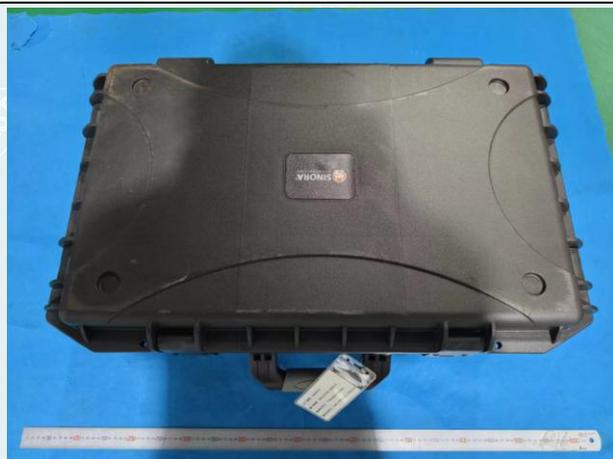
Fig.1-1 Sample appearance inspection before test

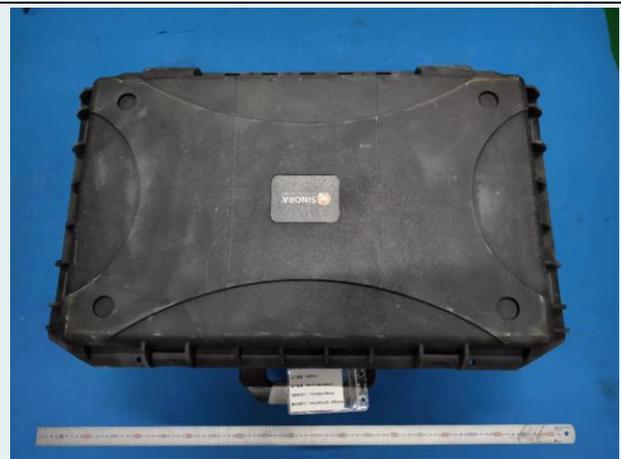
Fig.1-2 Sample appearance inspection after test

Test No.	Test Results	Conclusion
H202403271022-0004	The 1mm metal probe did not enter the sample shell, and no dust entered the inside of the subject after the test	Meet the requirement

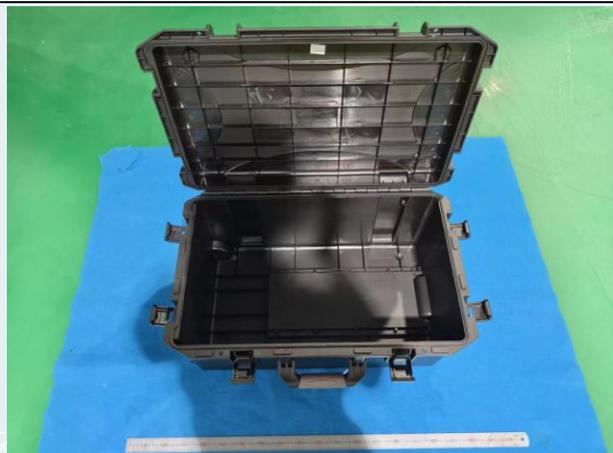
Fig.1-3 Sample appearance inspection before test

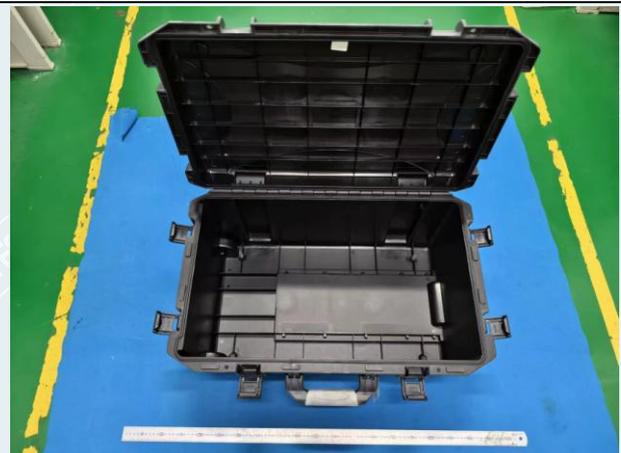
Fig.1-4 Sample unpacking inspection after test

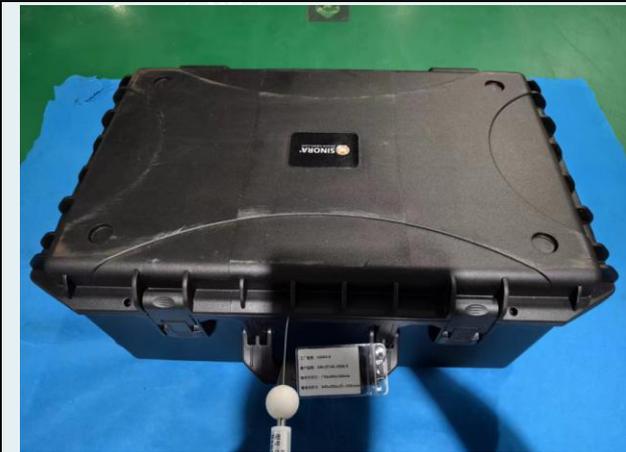
Fig.1-5 Metal probe inspection before test

1.1.2.1 Degrees of protection against access: use a metal probe with a diameter of 1.0mm to detect the shell of the tested product with a force of $1N \pm 0.1N$.

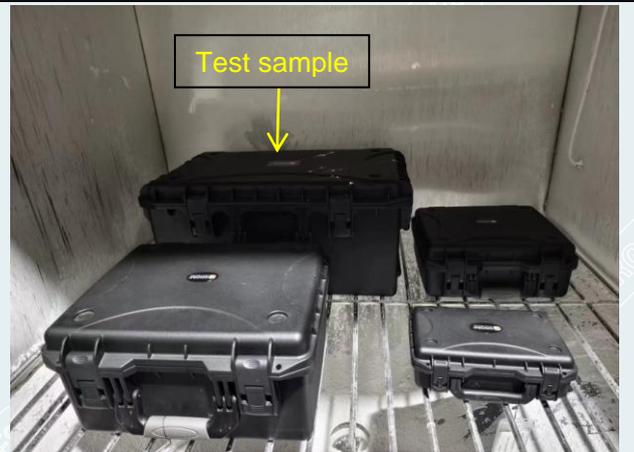
Fig.1-6 Test sample placement

1.1.2.2 Degrees of protection against foreign objects: fix the tested product in the test box and carry out the test according to the items in Table 1-1.

Test dust	Dosage of dust	Test time
Arizona powder	2kg/m ³	6s blowing dust, 15min standing, this is a cycle, running 20 cycles

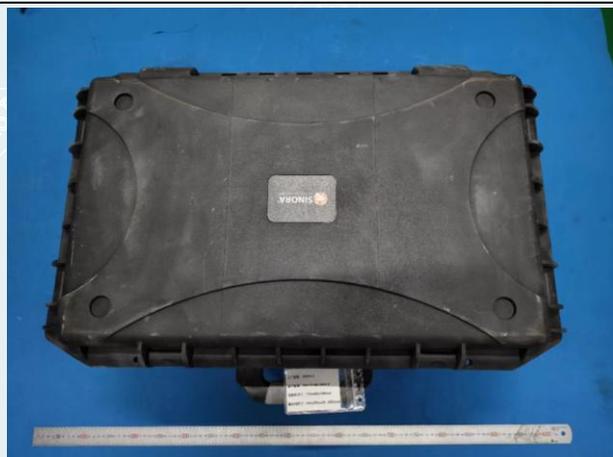
Fig.2-1 Sample appearance inspection before test

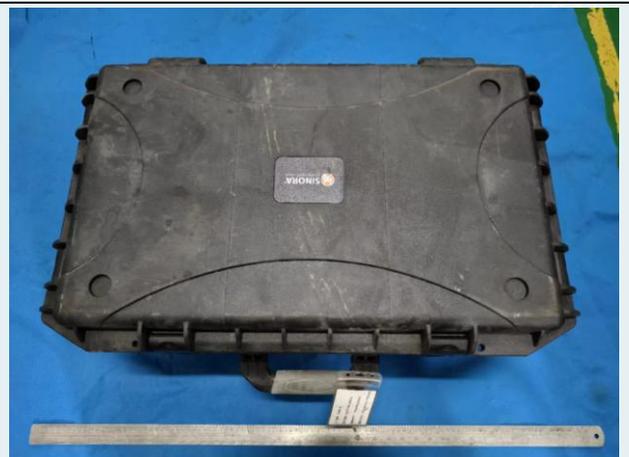
Fig.2-2 Sample appearance inspection after test

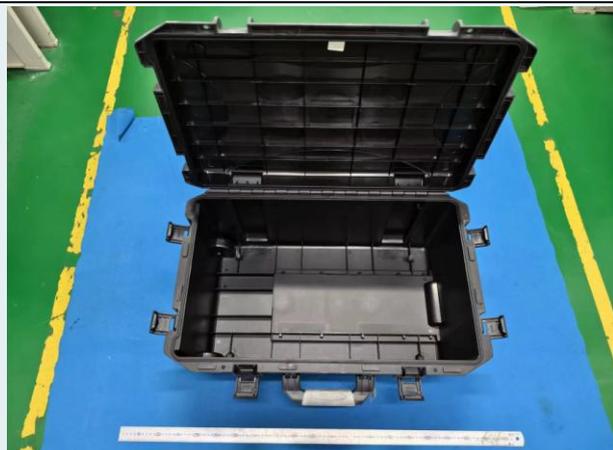
Fig.2-3 Sample unpacking inspection before test

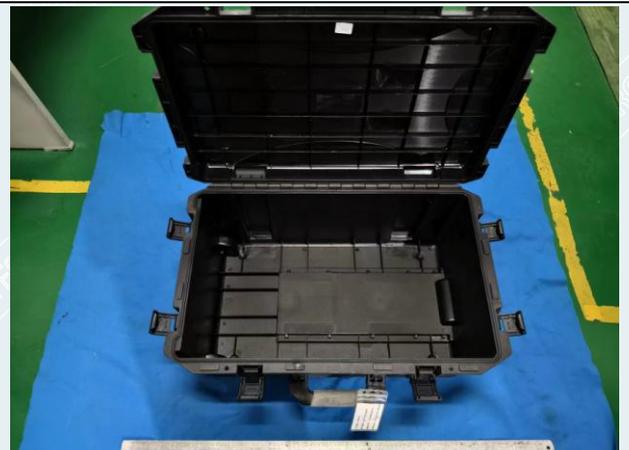
Fig.2-4 Sample unpacking inspection after test

Test No.	Test Results	Conclusion
H202403271022-0004	After the experiment, there is no water inside the measured object.	Meet the requirement

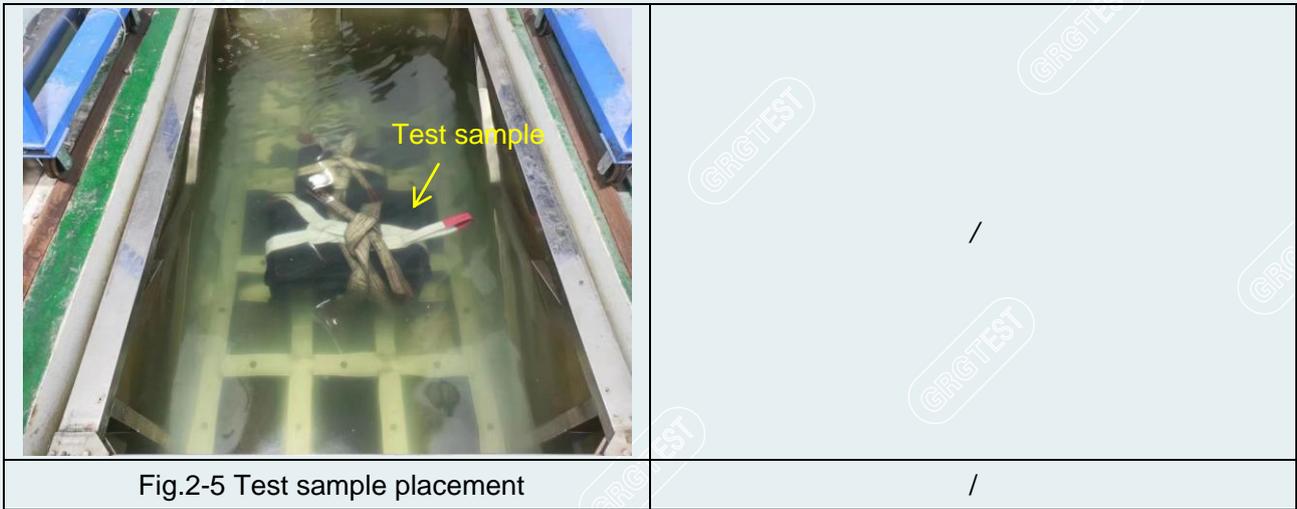
Fig.2-5 Test sample placement

2.1.2 Waterproof test: Fix the sample in the dipping tank and test according to the conditions listed in Table 2-1.

Distance between the highest point of the box body and the water surface	Test time
1000mm	Soak 30min
