# Test Report

Report No.:H20240903144001-03EN

Sample Name: Sinora Hard Shell Case

Reference  
Document: ISO 20653: 2013

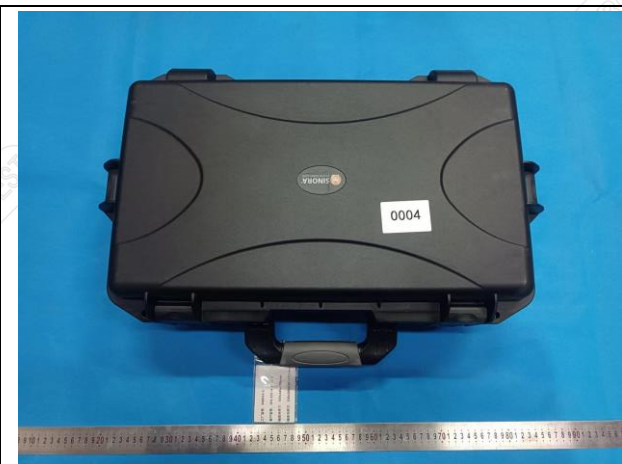
Fig.1-1 Sample before test

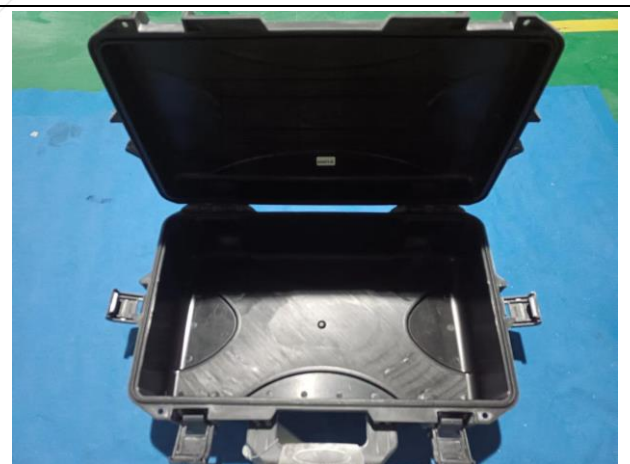
Test No.	Test Result	Conclusion
H202409031440-0004	The 1mm diameter detection line did not enter the shell of the test article, and no dust entered the interior of the test article after the test.	Meet the requirements

Fig.1-2 Unpacking and inspection after test

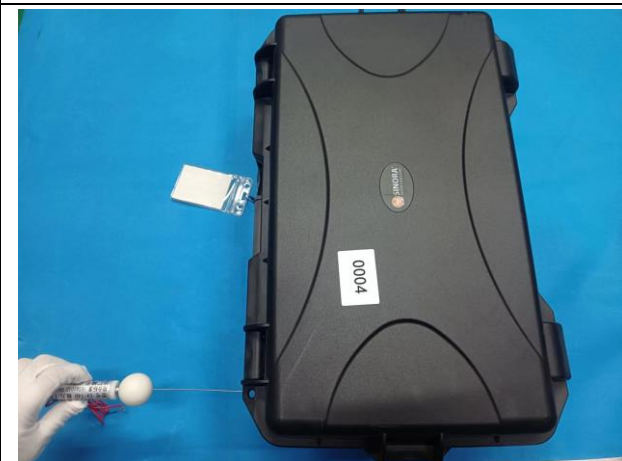
1.1.2.1 Anti-touch protection level: Probe the shell of the test article with a metal wire of 1.0mm in diameter with a force of  $1N \pm 0.1N$ ;

Fig.1-3 Pre-test metal probe inspection

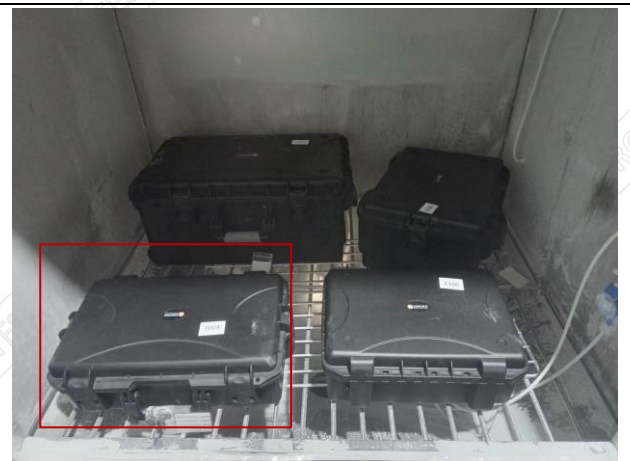
1.1.2.2 Anti-foreign object protection level: place the test item in the test box and test it according to the conditions in Table 1-1.

Tust Dust	Dust dosage	Test time
Arizona Powder	2kg/m <sup>3</sup>	Take 6s dust raising, 15min static as a cycle, run 20 cycles

Fig.1-4 Test set-up diagram

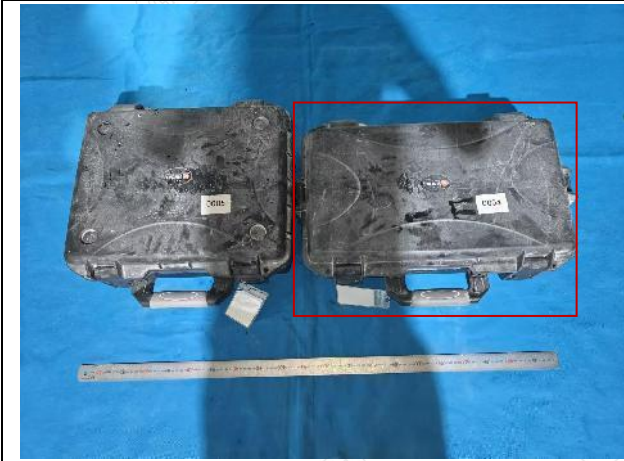
Fig.2-1 Sample before test

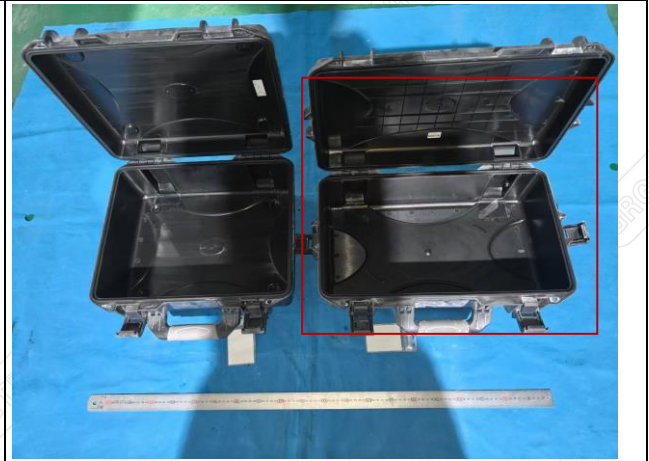
Test No.	Test Result	Conclusion
H202409031440-0004	No water ingress inside the sample after the test.	Meet the requirements

Fig.2-2 Unpacking and inspection after test

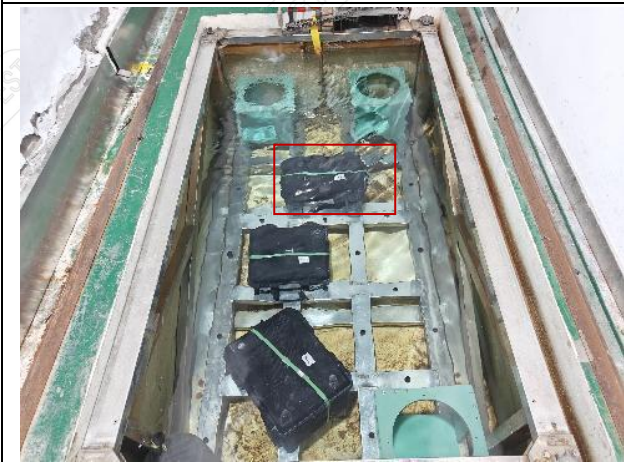
2.1.2 Test method: fix the test article in the immersion pool and conduct the test according to the conditions in Table 2-1;

Distance between the highest point of the box and the water surface	Test time
1000mm	30min

Fig.2-3 Test set-up diagram
