No.: H202312204372-01EN

SINORA HARD SHELL
Test report
(Environment Test)

February 2024

Sample Model : SIN-03630-19BK-E

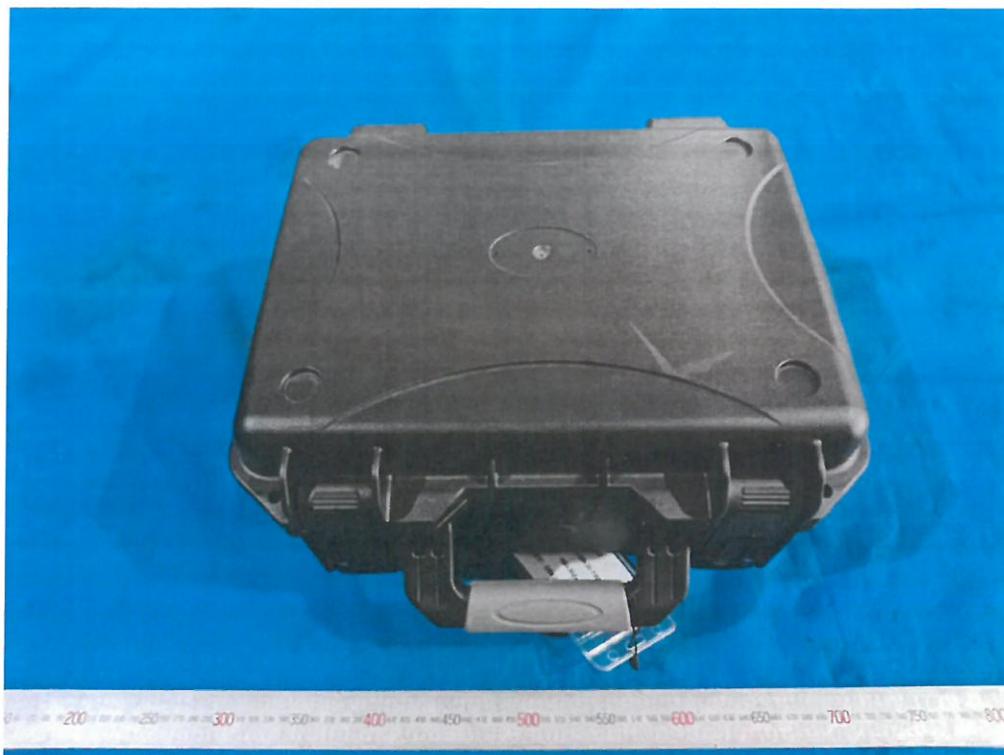
Figure 1-1 Full picture of subjects (Test No.:H202312204372-0001)

See Fig.1-1 for the full picture of the subjects in this experiment.

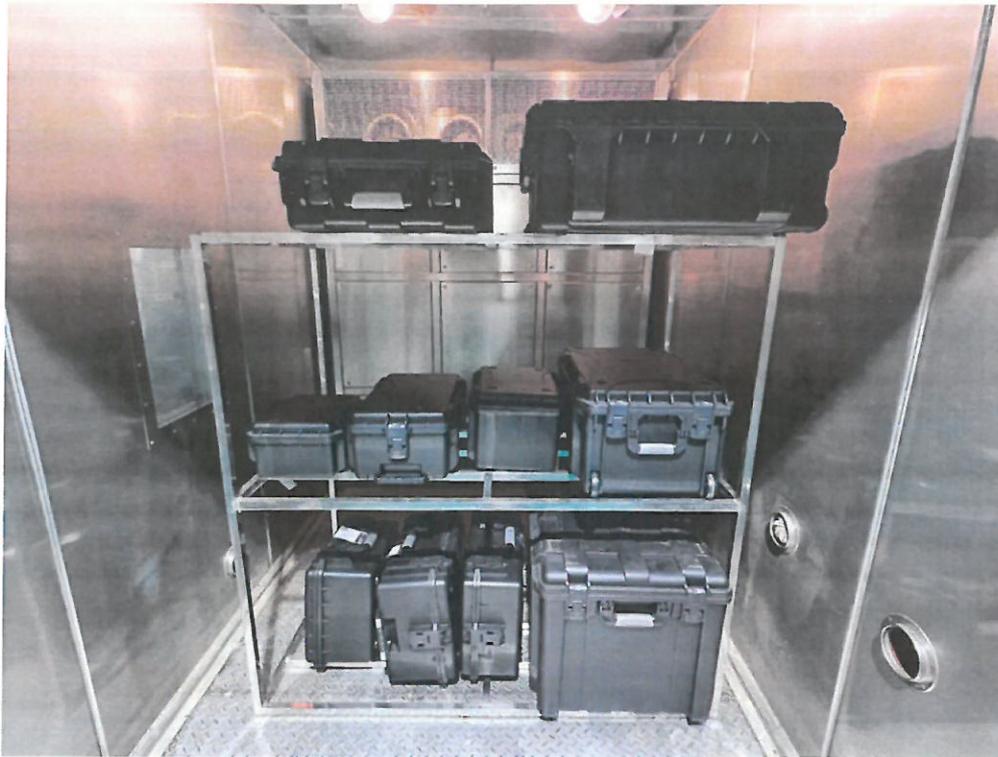
Attached figure 2.1 Temperature shock test subject placement diagram (H202312204372-0001)

The temperature shock test is carried out on the subject according to the test conditions specified in 2.1.2. The test started from the low temperature stage. During the test, the high temperature was 70°C, the low temperature was -10°C, the holding time of high and low temperature was 2h, and the conversion time of high and low temperature was about 60s. A total of 3 cycles were carried out。

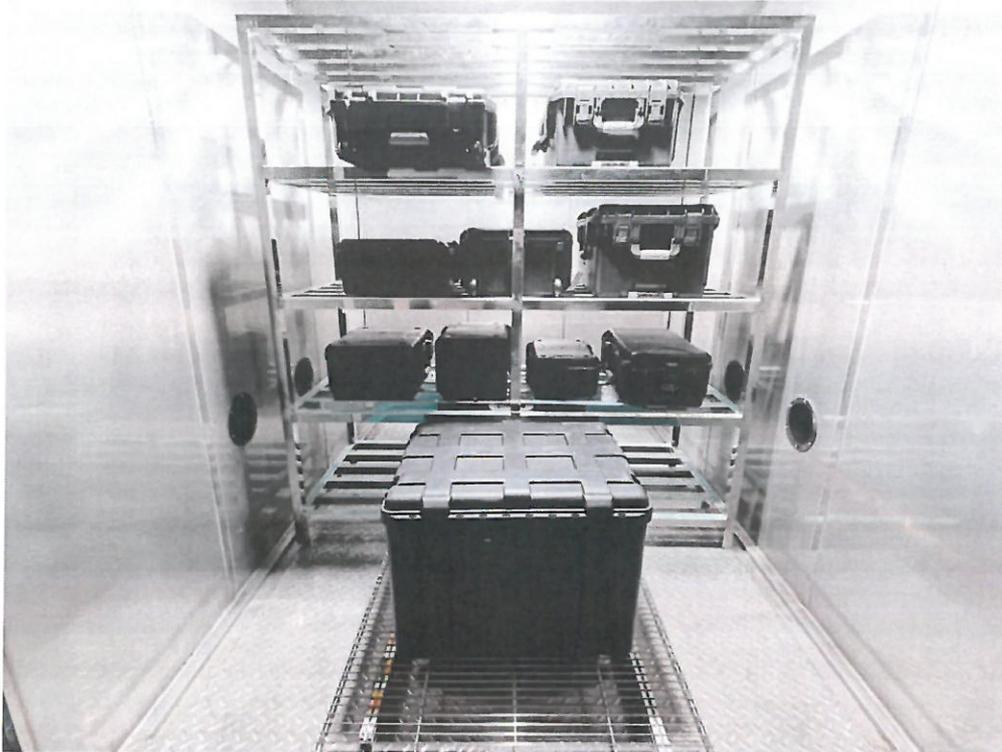
Attached figure 2.3 Temperature impact test subject placement diagram (H202312204372-0001)

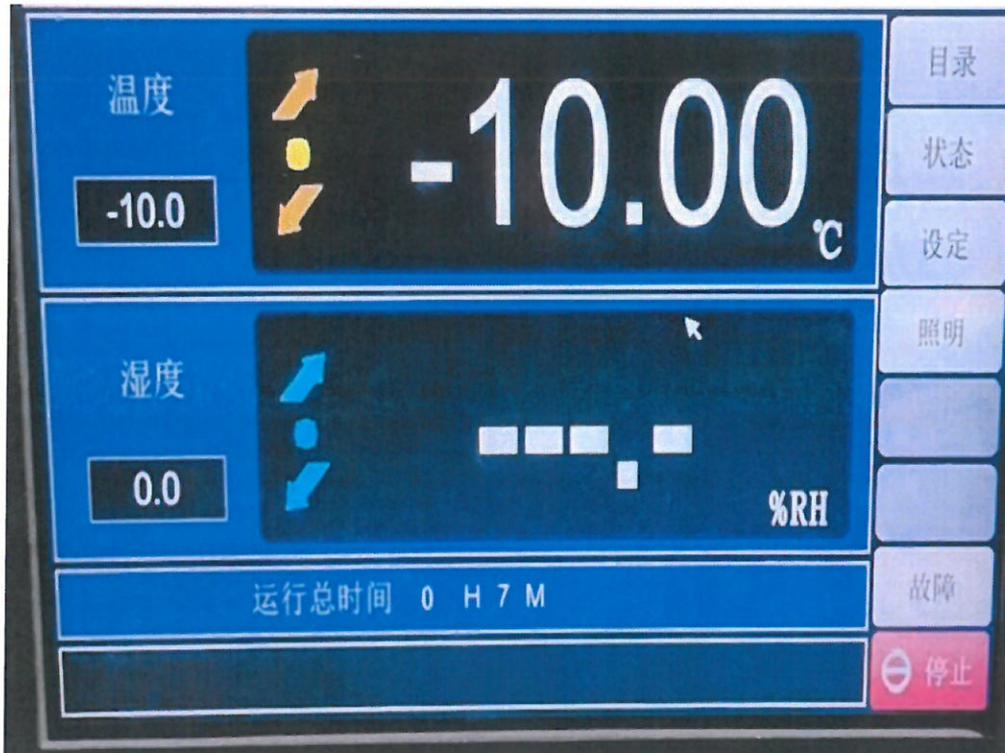
Attached figure 2.4 Temperature shock test equipment running interface-cryogenic box (H202312204372-0001)

During the test, the test equipment ran normally and met the test conditions stipulated in Article 2.1.2. See Annex 2 for the interface diagram of the test temperature。

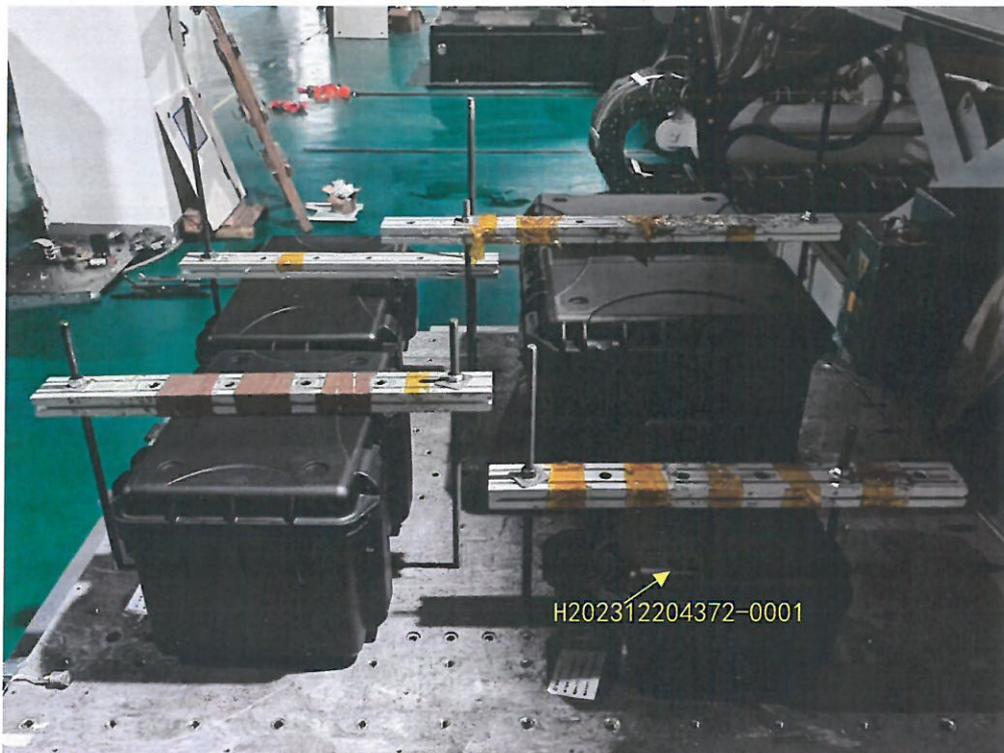
Attached figure 2.6 The vibration test is typically set up by the sample-Y axis (H202312204372-0001)

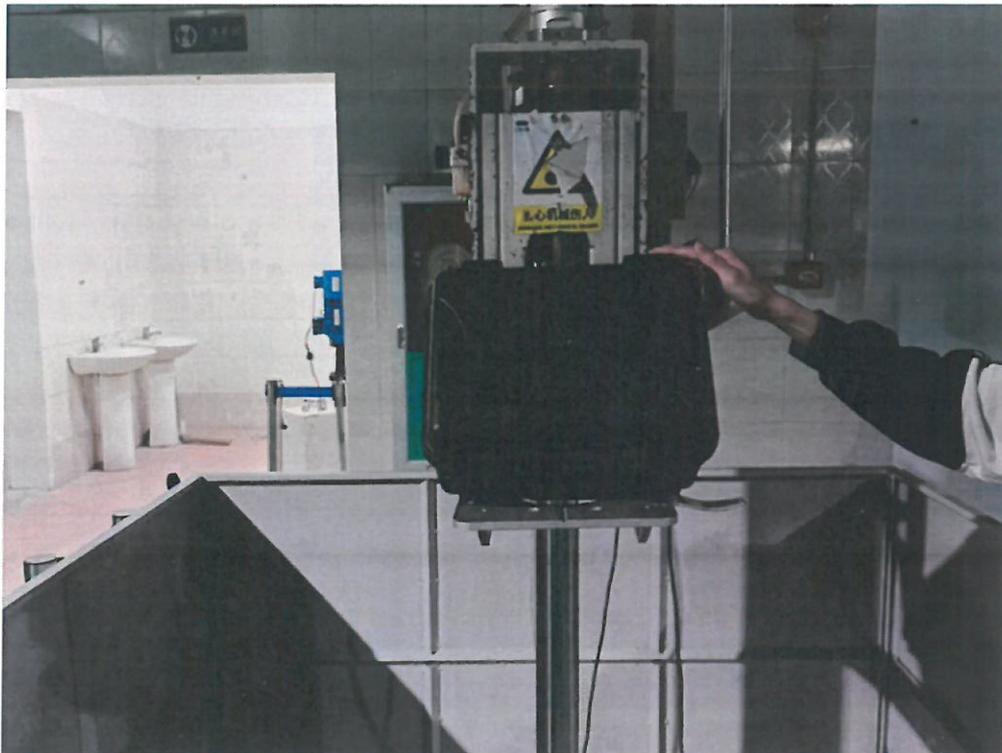
Attached figure 2.14 Drop test subjects erection typical diagram - Edge

Step 1: Press 2.3.2 table 2-3 test conditions to place the subjects on the drop shelf, in height 122cm, to fall on the 12 edges of the subjects。

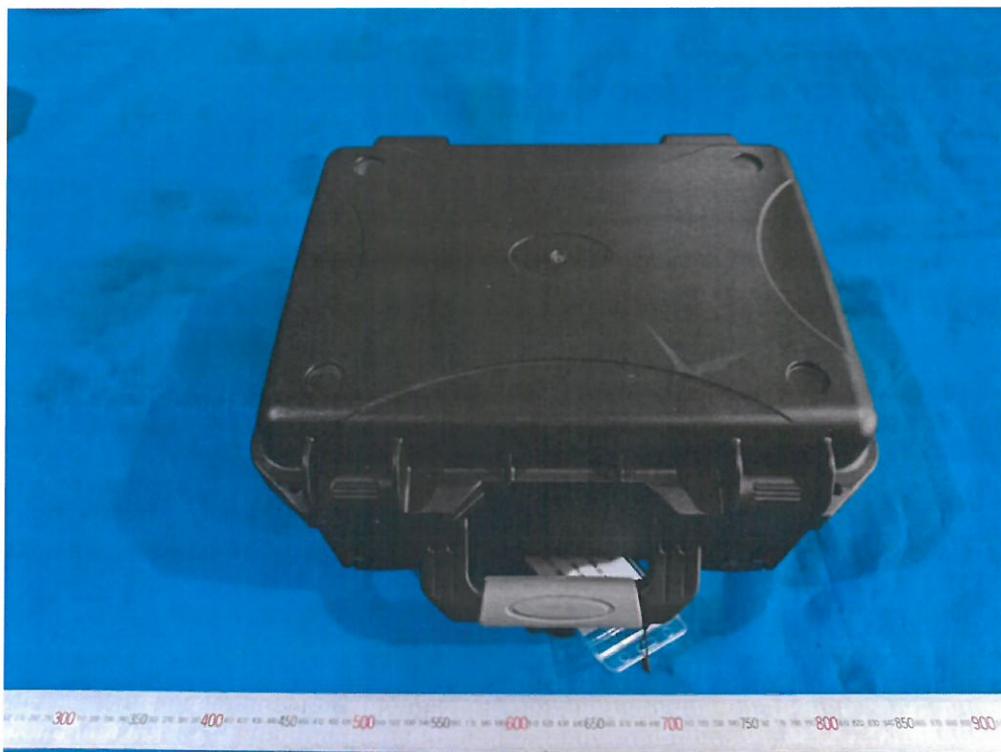
Attached figure 2.18 Typical drawing of appearance inspection of subject (H202312204372-0001)
