SINORA HARD SHELL
Test report
(Environment Test)

SINORA HARD SHELL

Sample Model : SIN-07146-28BK-E

Sample Name : SINORA HARD SHELL

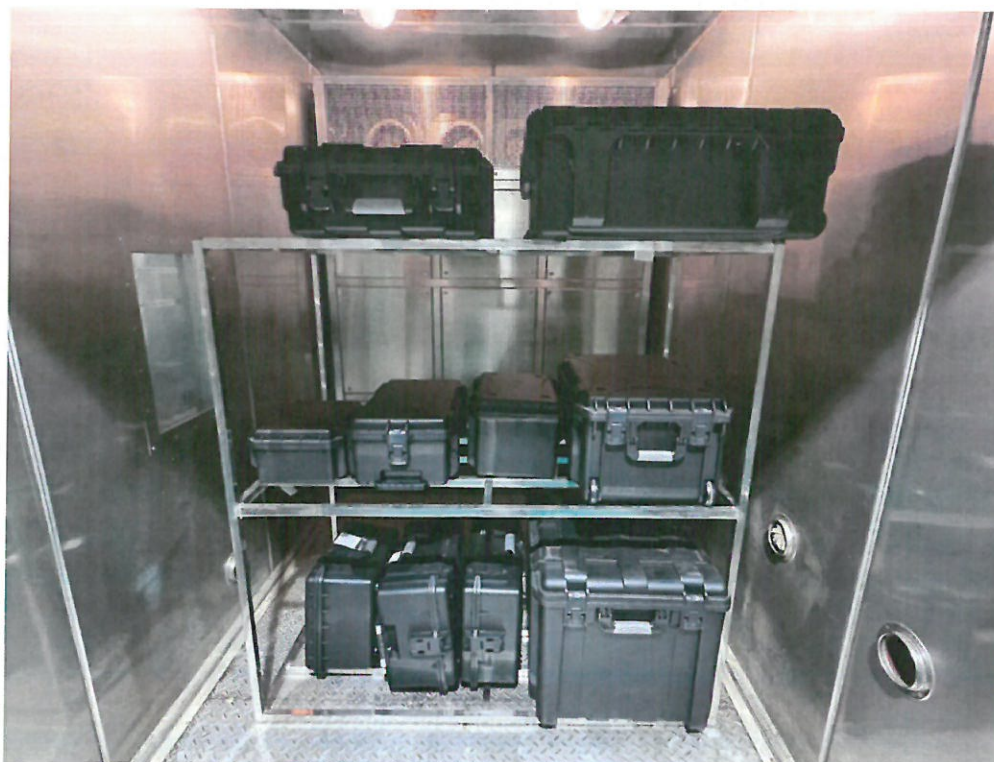
Attached figure 2.1 Temperature shock test subject placement diagram (H202312204372-0007)

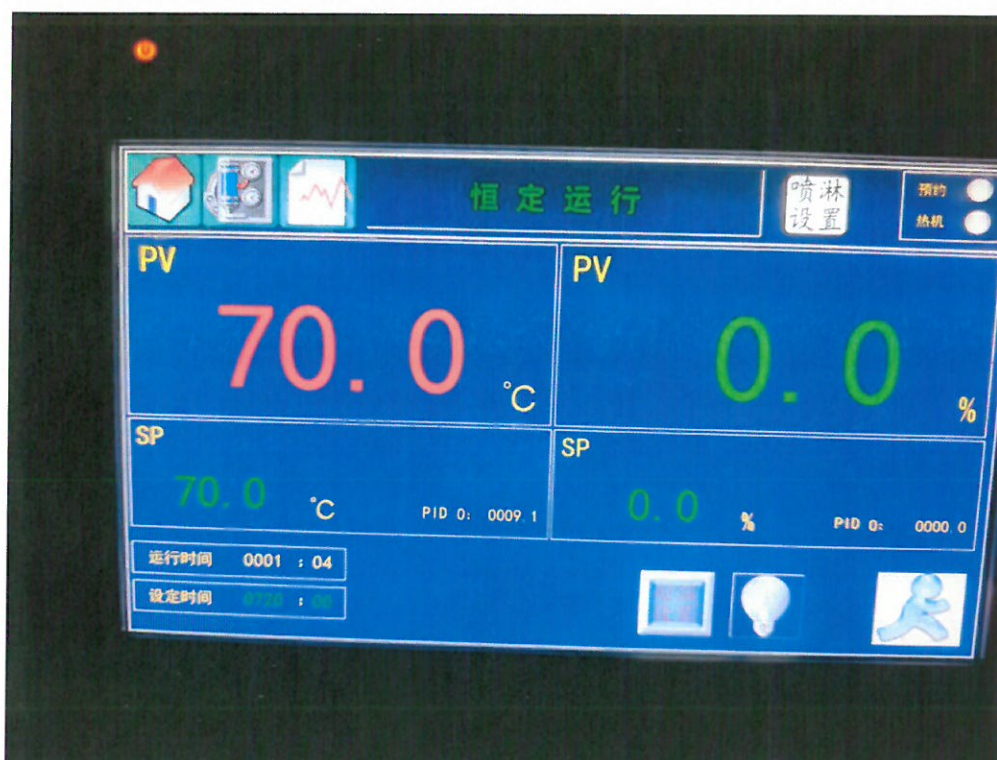
Attached figure 2.2 Temperature shock test equipment running interface - high temperature box (H202312204372-0007)

During the test, the test equipment ran normally and met the test conditions stipulated in Article 2.1.2. See Annex 2 for the interface diagram of the test temperature。

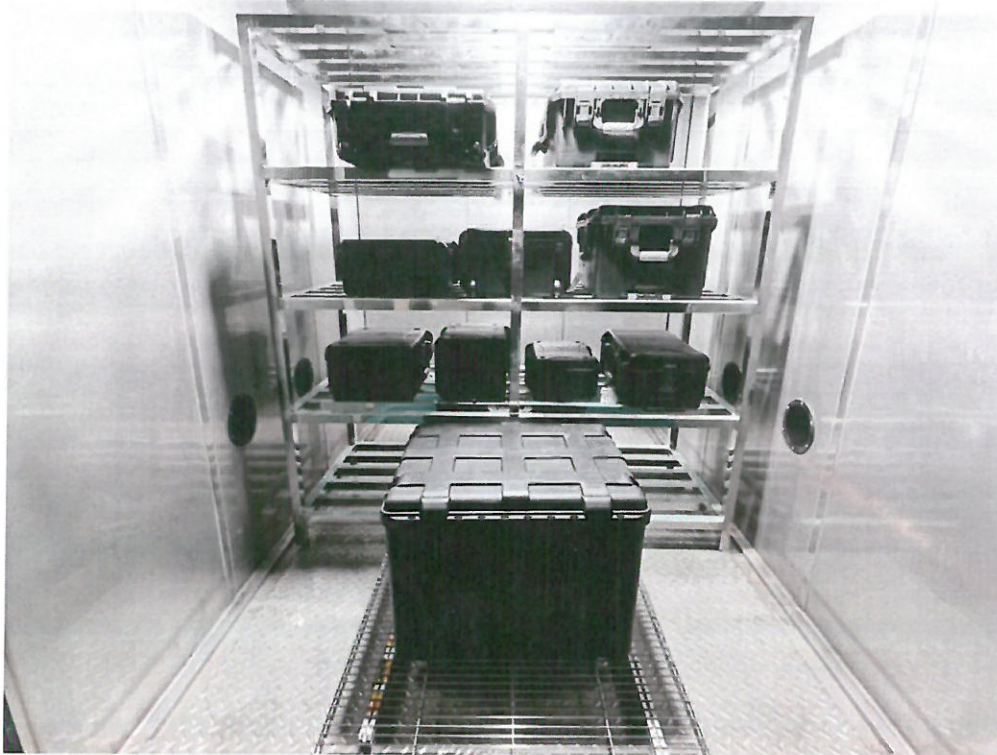
Attached figure 2.3 Temperature impact test subject placement diagram (H202312204372-0007)

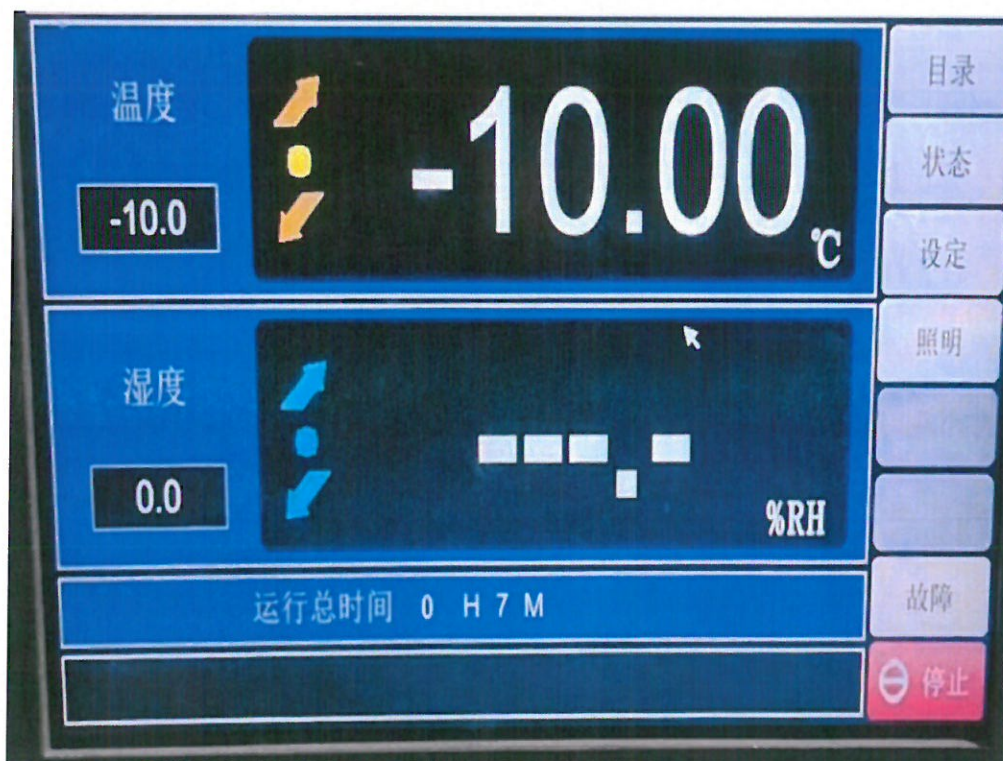
Attached figure 2.4 Temperature shock test equipment running interface-cryogenic box (H202312204372-0007)

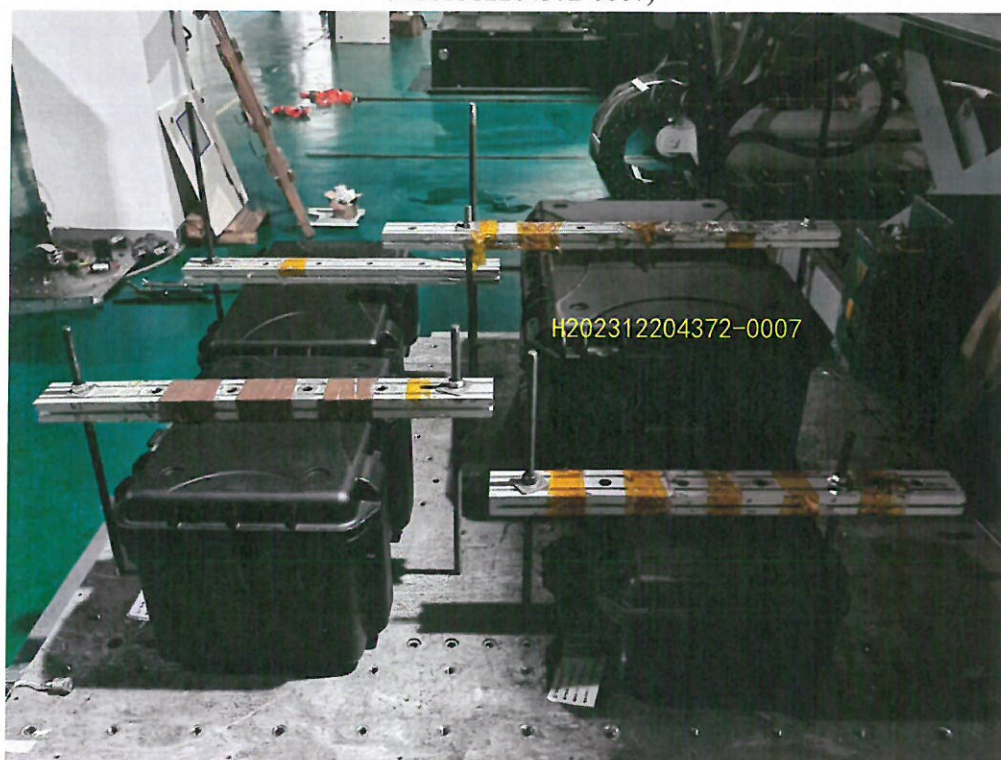
Attached figure 2.6 The vibration test is typically set up by the sample-Y axis
(H202312204372-0007)

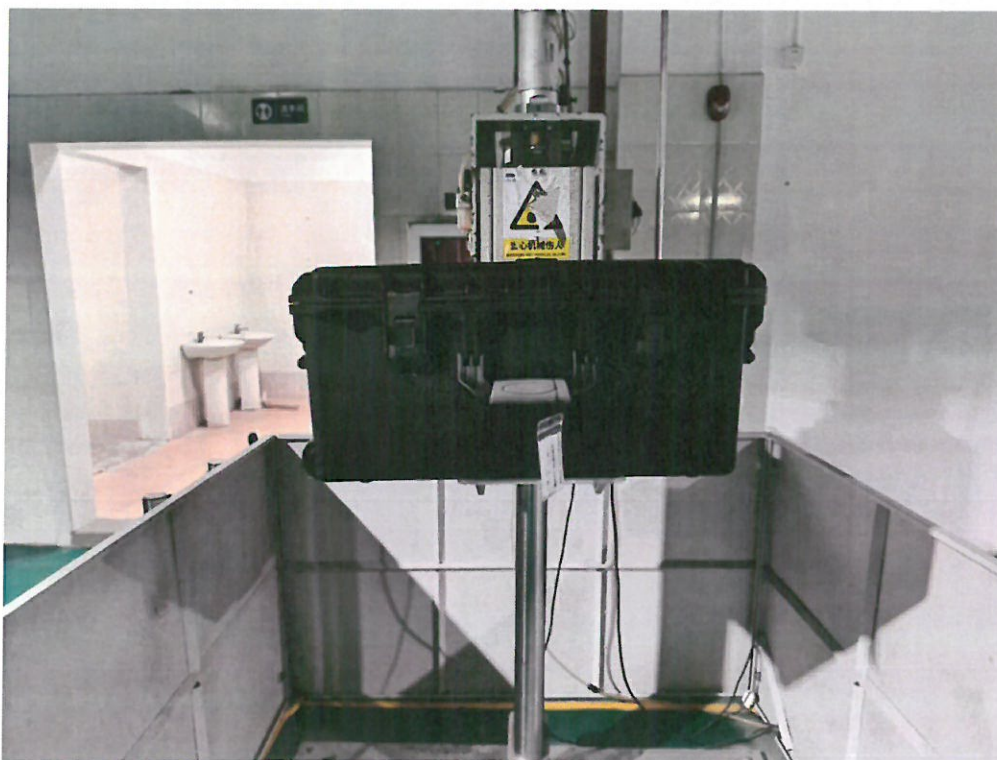
Attached figure 2.16 Drop test subjects set up typical figure-Face

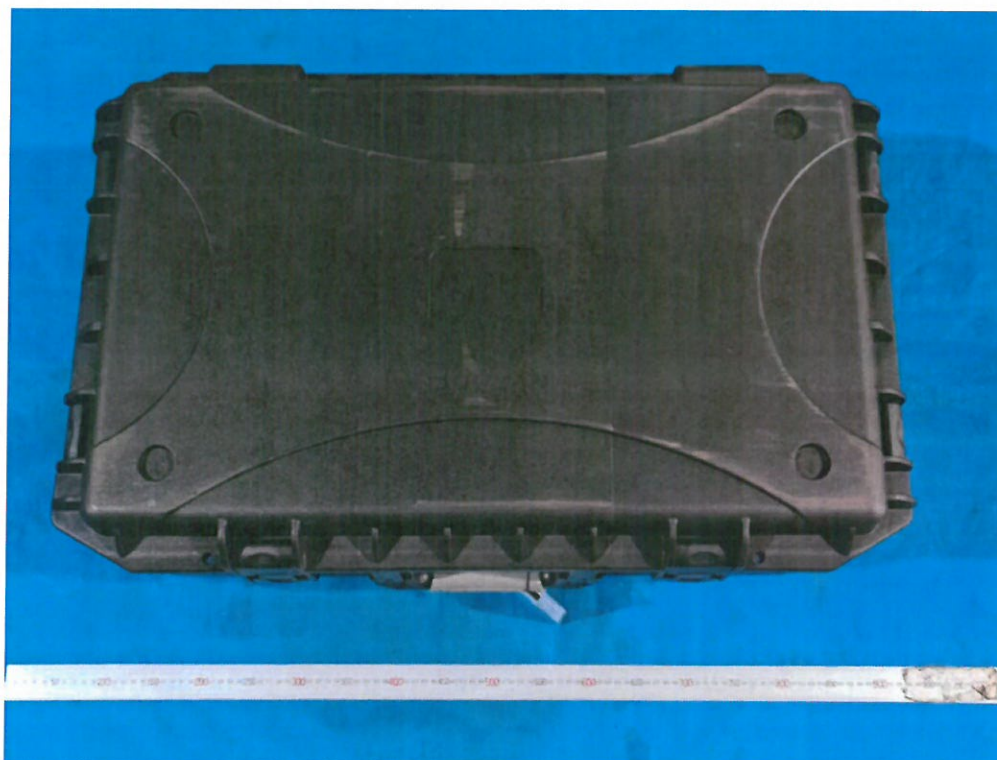
Attached figure 2.18 drawing of appearance inspection of subject
(H202312204372-0007)
