Test Report

Report No.:H202403271022-01EN

Sample Name: SINORA HARD SHELL

Reference
Document: According to ISO 20653:2013

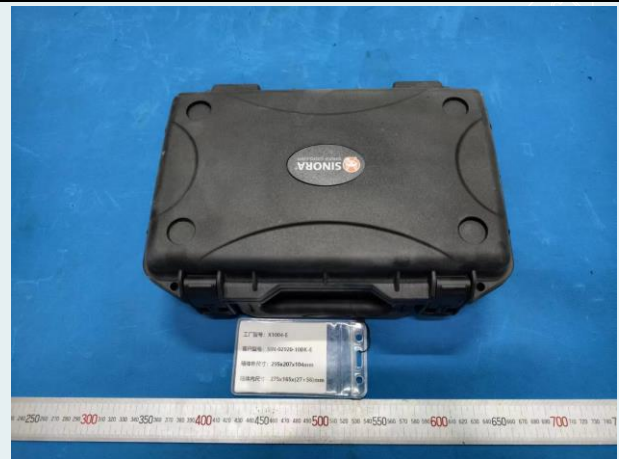
Fig.1-2 Sample appearance inspection after test

| Test No. | Test Results | Conclusion |
|---|--|---|
| H202403271022-0001 | The 1mm metal probe did not enter the sample shell, and no dust entered the inside of the subject after the test | Meet the requirement |

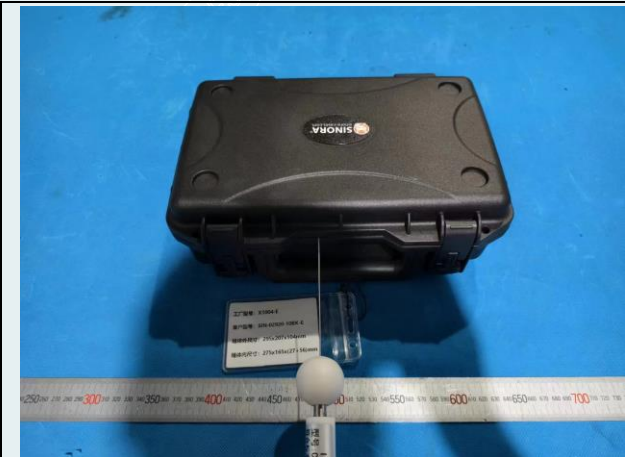
Fig.1-5 Metal probe inspection before test

1.1.2.1 Degrees of protection against access: use a metal probe with a diameter of 1.0mm to detect the shell of the tested product with a force of $1N \pm 0.1N$.

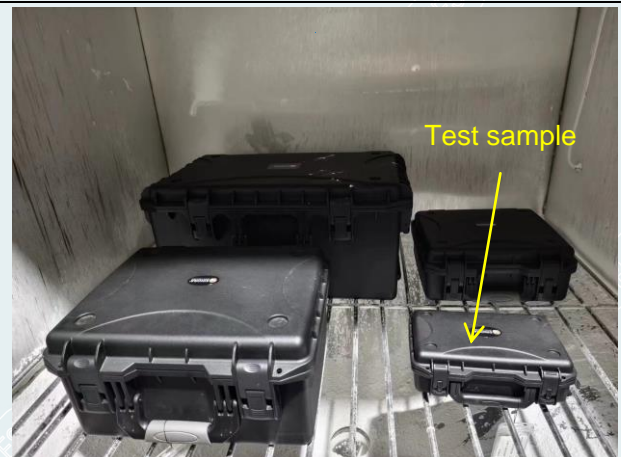
Fig.1-6 Test sample placement

1.1.2.2 Degrees of protection against foreign objects: fix the tested product in the test box and carry out the test according to the items in Table 1-1.

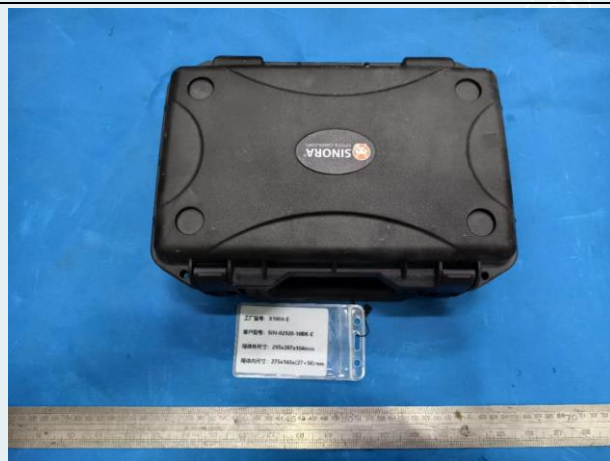
Fig.2-2 Sample appearance inspection after test

| Test No. | Test Results | Conclusion |
|---|---|---|
| H202403271022-0001 | After the experiment, there is no water inside the measured object. | Meet the requirement |
