# Test Report

Report No.:H202502262097-17EN

Sample Name: SINORA HARD SHELL

Reference  
Document: MIL-STD-810H-2019

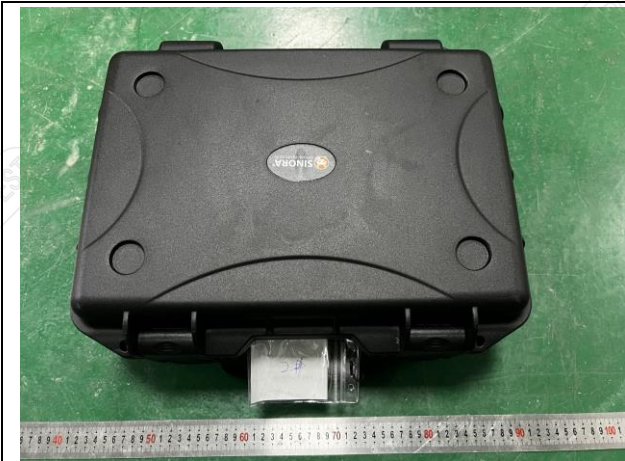
Fig.1-1 Sample appearance before test

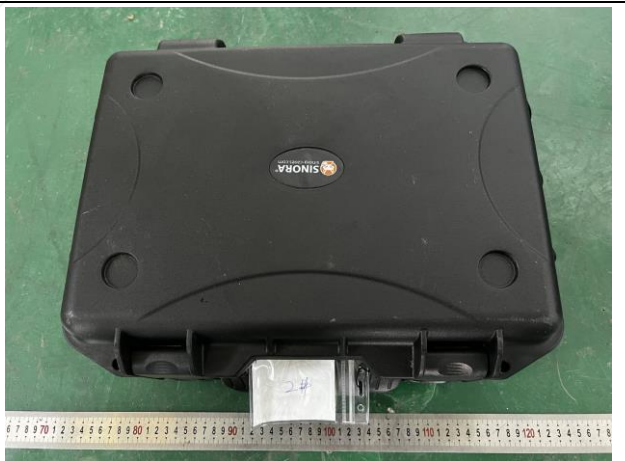
Test No.	Test result	Conclusion
H202502262097-0002	After the test, the appearance of the sample is not cracked, unglued and damaged.	Meet the requirements

Fig.1-2 Sample appearance after test

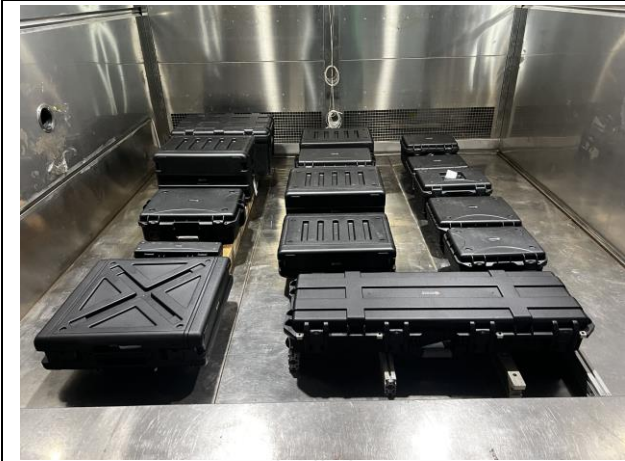
1.1.3 Experimental operation: The experiment starts from the low temperature range. During the experiment, the high temperature is 80 °C and the low temperature is -30 °C. The holding time for both high and low temperatures is 2 hours, and the transition time between high and low temperatures is no more than 1 minute. A total of 3 cycles are conducted;

Fig.1-3 Low temperature test erection

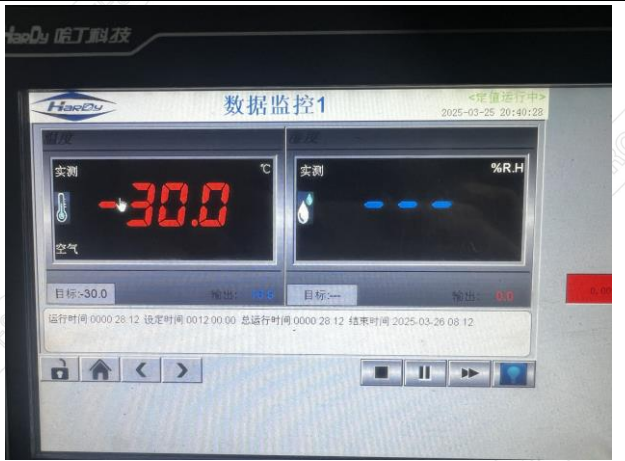
Fig.1-4 Low temperature operating interface

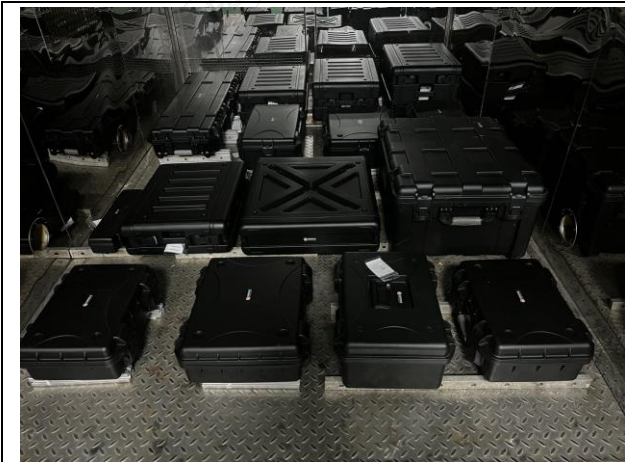
Fig.1-5 High temperature test erection

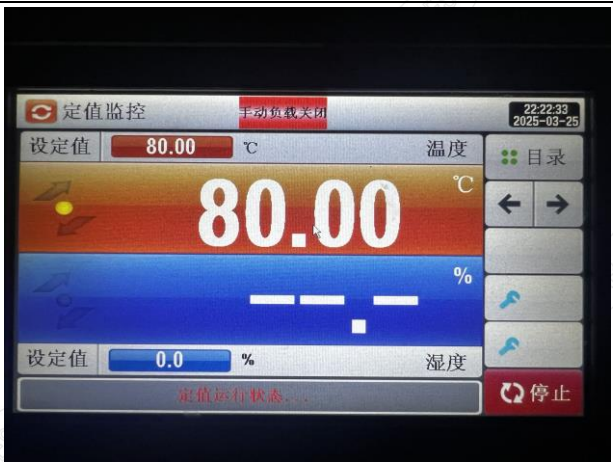
Fig.1-6 High-temperature operating interface

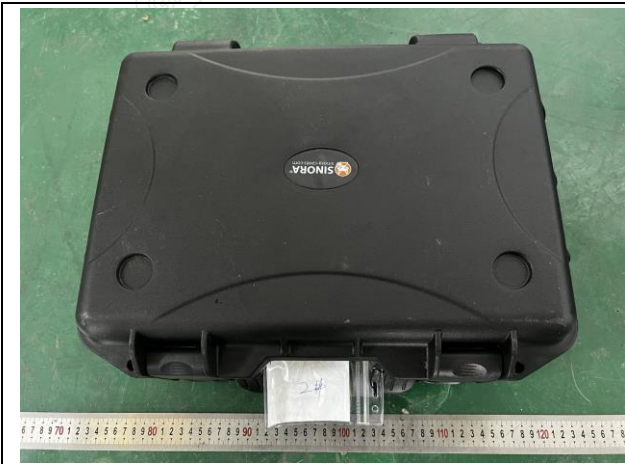
Fig.2-1 Sample appearance before test

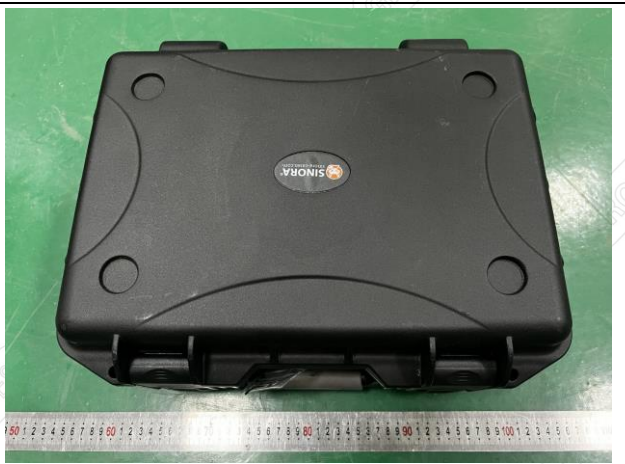
Test No.	Test result	Conclusion
H202502262097-0002	After the test, the appearance of the sample is not cracked, unglued and damaged.	Meet the requirements

Fig.2-2 Sample appearance after test

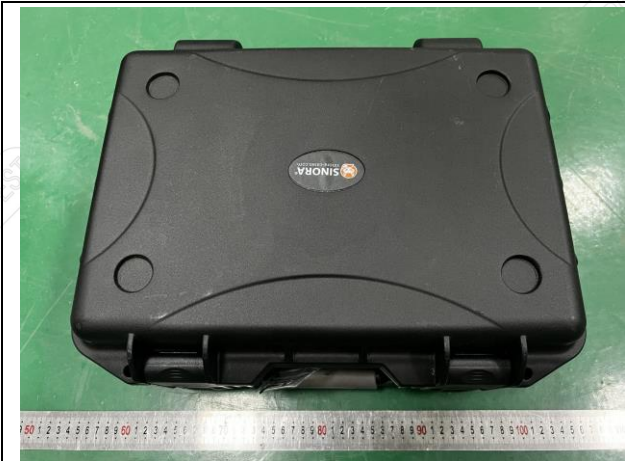
Fig.3-1 Sample appearance before test

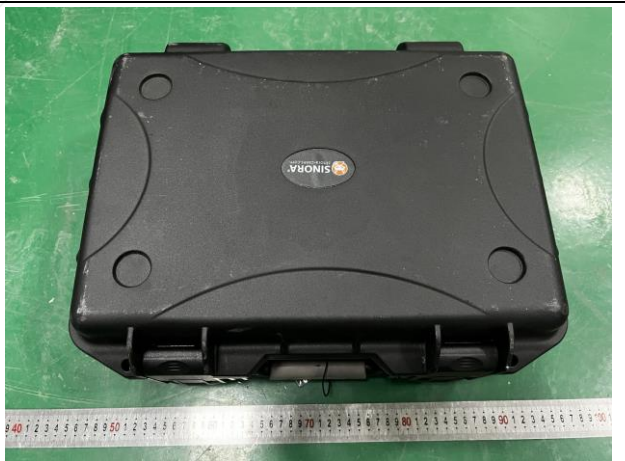
Test No.	Test result	Conclusion
H202502262097-0002	After the test, the appearance of the sample is not cracked, unglued and damaged.	Meet the requirements

Fig.3-2 Sample appearance after test

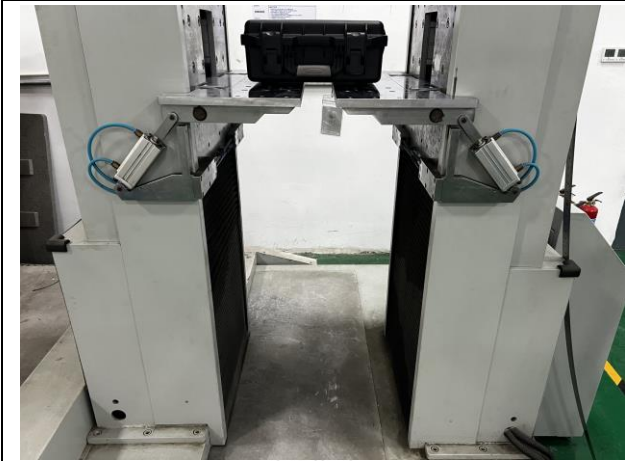
Falling Surface	Drop Height (cm)	Number Of Drops
12 edges	122	each edge once, a total of 12 times
8 corners	122	1 time per corner, a total of 8 times
6 faces	122	1 time per face, a total of 6 times

Fig.3-3 Test the erection-surface

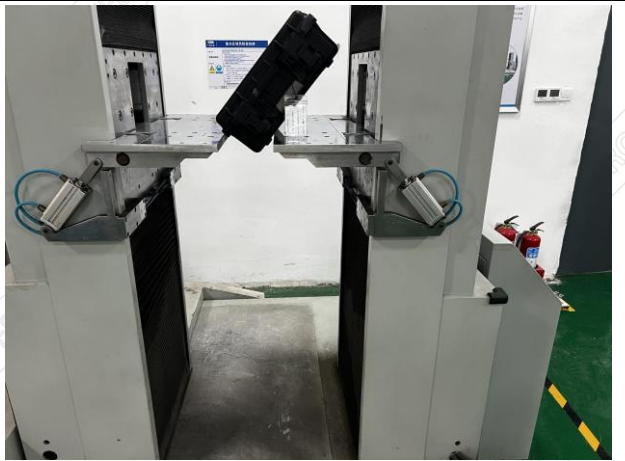
Fig.3-4 Test erection-edge
