Test Report

Report No.:H202502262097-23EN

Sample Name: SINORA HARD SHELL

Reference
Document: MIL-STD-810H-2019

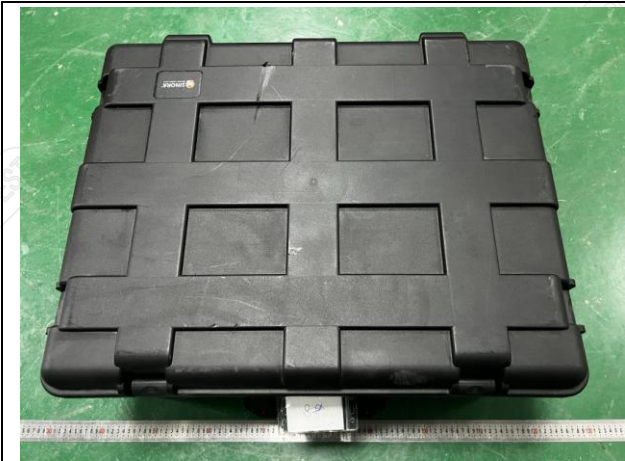
Fig.1-1 Sample appearance before test

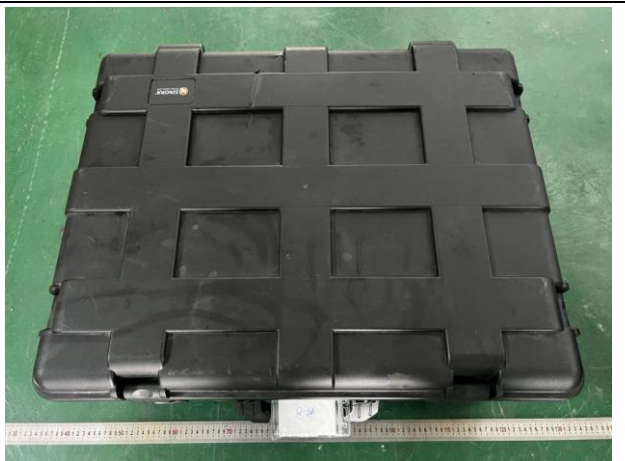
Fig.1-2 Sample appearance after test

Test No.	Test result	Conclusion
H202502262097-0008	After the test, the appearance of the sample is not cracked, unglued and damaged.	Meet the requirements

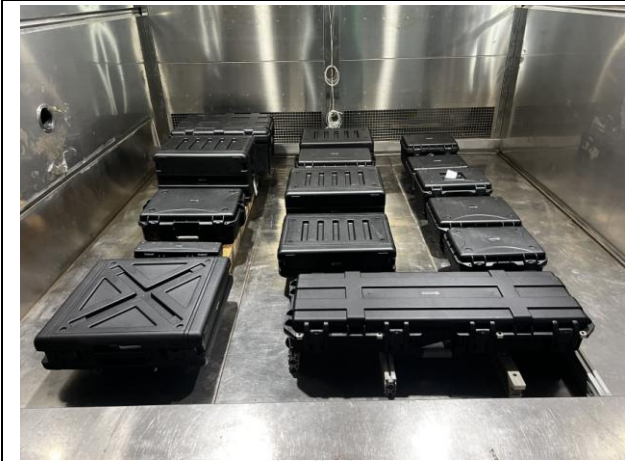
Fig.1-3 Low temperature test erection

1.1.3 Experimental operation: The experiment starts from the low temperature range. During the experiment, the high temperature is 80 °C and the low temperature is -30 °C. The holding time for both high and low temperatures is 2 hours, and the transition time between high and low temperatures is no more than 1 minute. A total of 3 cycles are conducted;

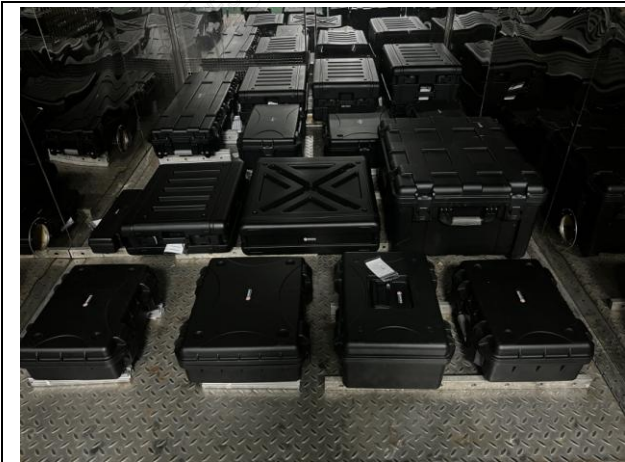
Fig.1-5 High temperature test erection

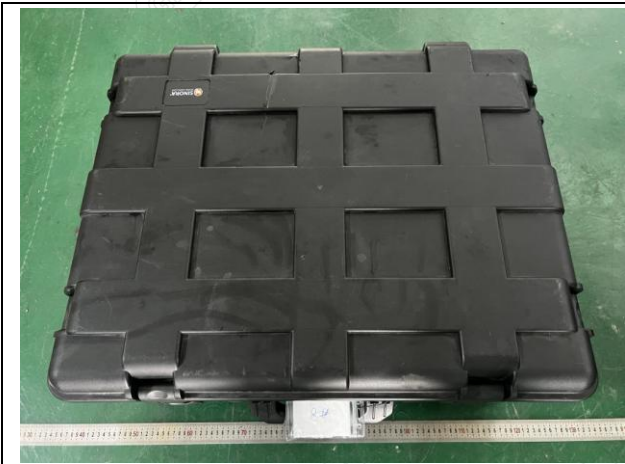
Fig.2-1 Sample appearance before test

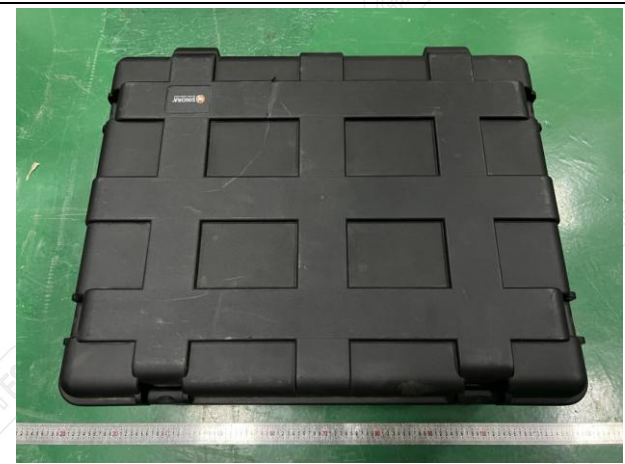
Fig.2-2 Sample appearance after test

Test No.	Test result	Conclusion
H202502262097-0008	After the test, the appearance of the sample is not cracked, unglued and damaged.	Meet the requirements

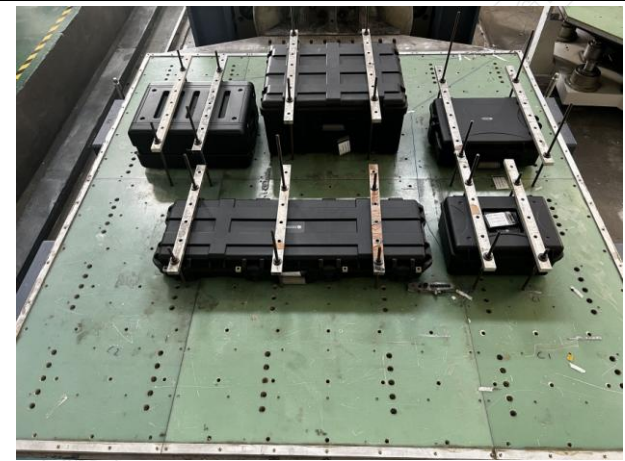
Fig.2-4 Test erection (Y-axis)

2.1.2 Sample Installation And positioning: Install the test sample on the fixture, then rigidly fix the fixture on the vibration table, install control sensors on the bottom bracket of the test sample, and use two-point average control method;

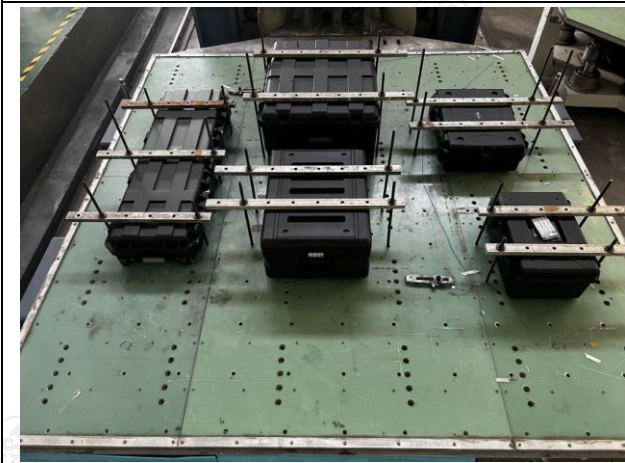
Fig.2-5 Test erection (X-axis)

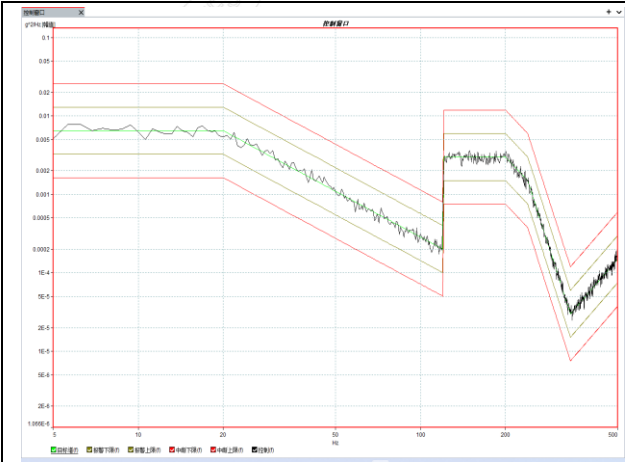
Fig.2-7 Road transport vibration test curve (Y-axis)

Z-Axis (Vertical)		X-Axis (Transverse)		Y-Axis (longitudinal)		Test axis and its time
Frequency (Hz)	Acceleration (g^2/Hz)	Frequency (Hz)	Acceleration (g^2/Hz)	Frequency (Hz)	Acceleration (g^2/Hz)	
5	0.015	5	0.00013	5	0.0065	Vibration in horizontal, vertical, and vertical directions for 1 hour each
40	0.015	10	0.00013	20	0.0065	
500	0.00015	20	0.00065	120	0.0002	
/	/	30	0.00065	121	0.003	
/	/	78	0.00002	200	0.003	
/	/	79	0.00019	240	0.0015	
/	/	120	0.00019	340	0.00003	
/	/	500	0.00001	500	0.00015	
Root-Mean-Square Value: 1.08g		Root-Mean-Square Value: 0.21g		Root-Mean-Square Value: 0.76g

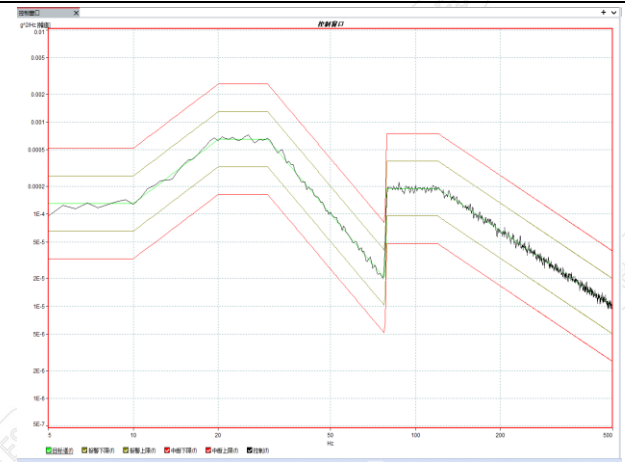
Fig.2-8 Road transport vibration test curve (X-axis)

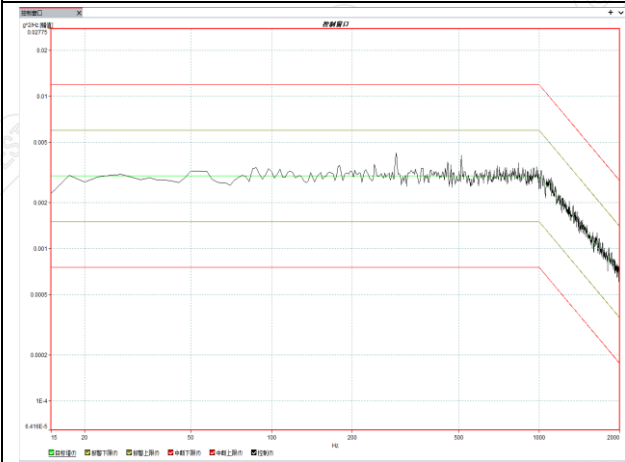
Fig.2-9 Jet vibration test curve (Z-axis)

Frequency (Hz)	Acceleration ((g) ² /Hz)	Left Slope (db/Oct)	Right Slope (db/Oct)	Test Axis And Time
15	0.003	0	0	Vibration in horizontal, vertical, and vertical directions for 1 hour each
1000	0.003	0	-6	
2000	0.0007	-6	0	
Root-Mean-Square Value: 2.11g

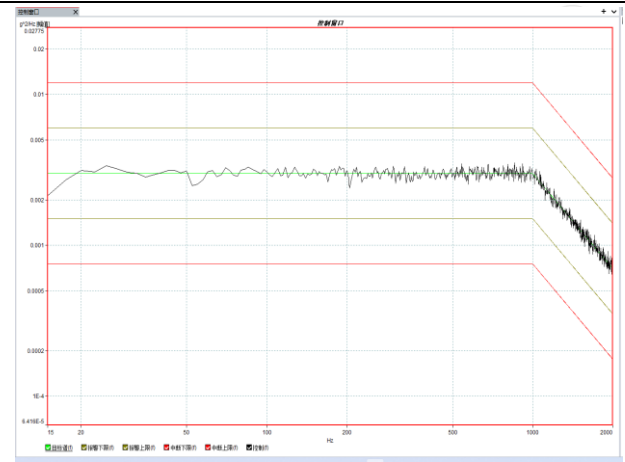
Fig.2-10 Jet vibration test curve (Y-axis)

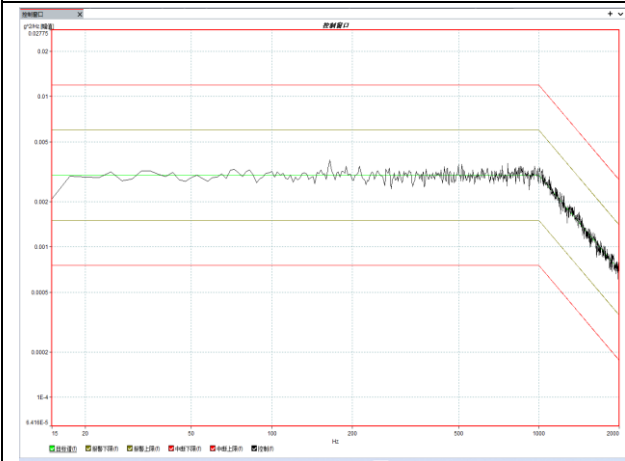
Fig.2-11 Jet vibration test curve (X-axis)

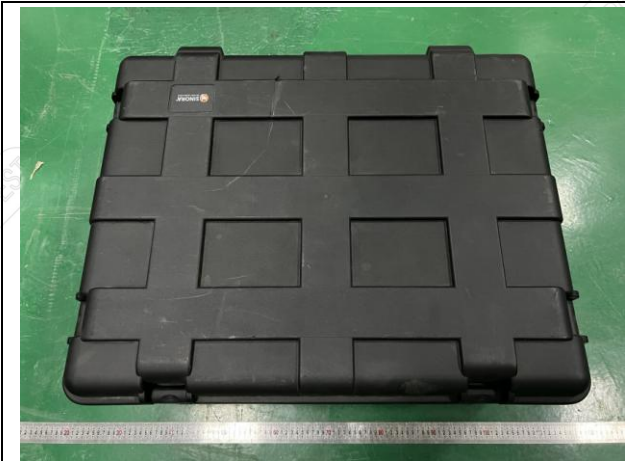
Fig.3-1 Sample appearance before test

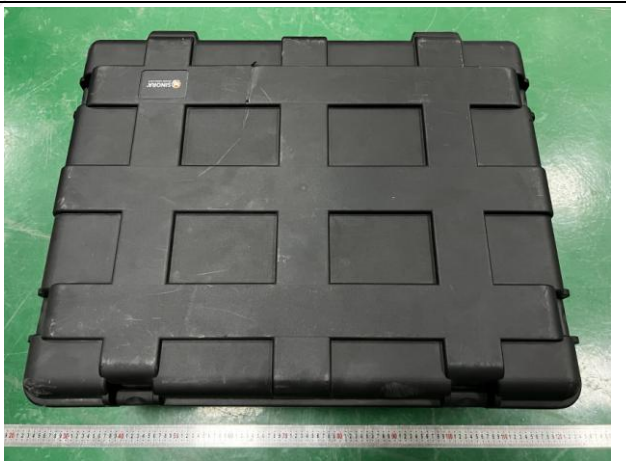
Fig.3-2 Sample appearance after test

Test No.	Test result	Conclusion
H202502262097-0008	After the test, the appearance of the sample is not cracked, unglued and damaged.	Meet the requirements

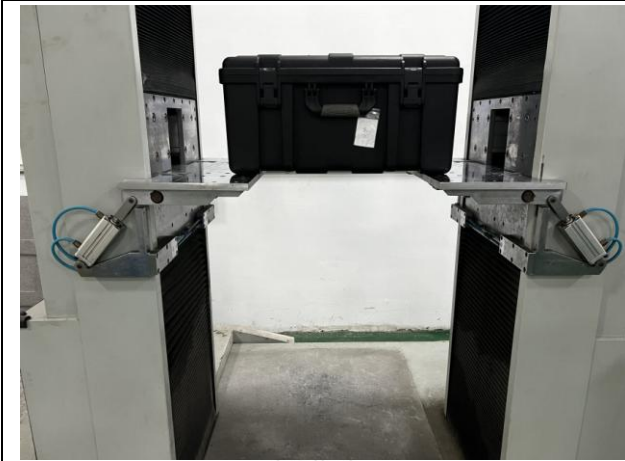
Fig.3-3 Test the erection-surface

Falling Surface	Drop Height (cm)	Number Of Drops
12 edges	122	each edge once, a total of 12 times
8 corners	122	1 time per corner, a total of 8 times
6 faces	122	1 time per face, a total of 6 times

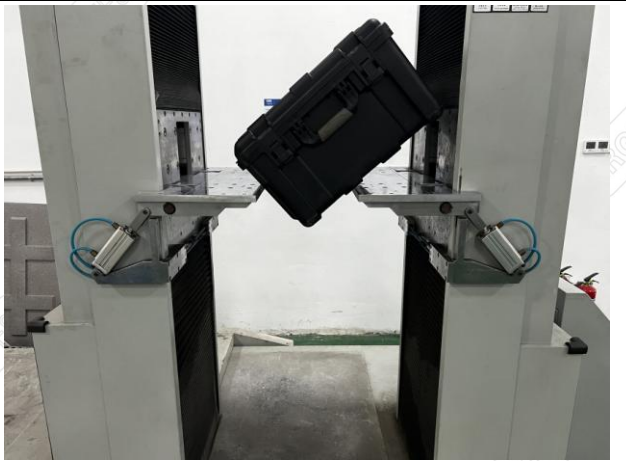
Fig.3-4 Test erection-edge
