Test Report

Report No.:H202505081935-03EN

Sample Name: SINORA HARD SHELL

Reference
Document: ISO 20653:2013

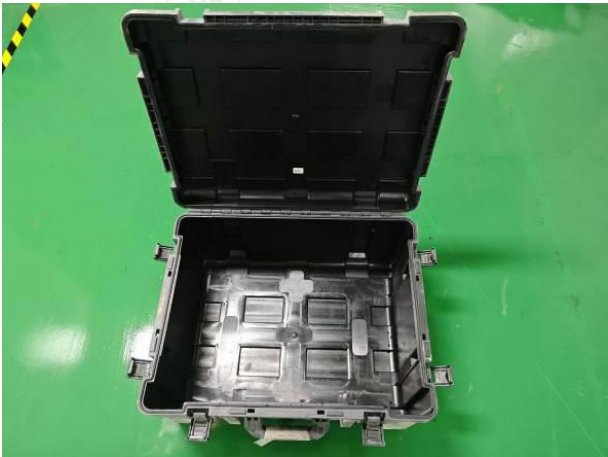
Test No.	Test result	Conclusion
H202505081935-0003	Before the test, the 1mm metal probe did not enter the sample shell. After the test, no dust seeped into the interior of the sample.	Meet the requirements

/
Fig 1-5 Internal inspection after the test (no dust entry)	/

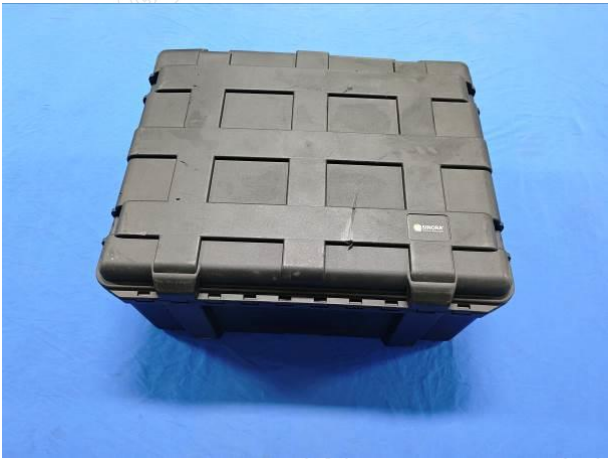
Fig 2-1 Sample before test	Fig 2-2 Sample after the test

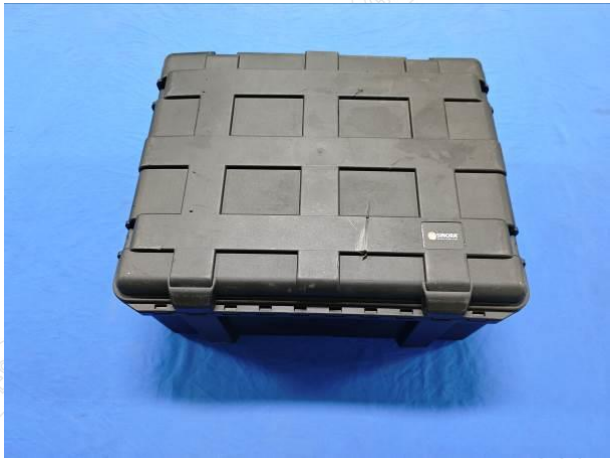
Test No.	Test result	Conclusion
H202505081935-0003	After the test, no water seepage occurred inside the sample.	Meet the requirements
